## Fairfield / Vacaville Train Station and Peabody Road Improvements

### Current Construction Status (UPDATED 08-10-16)

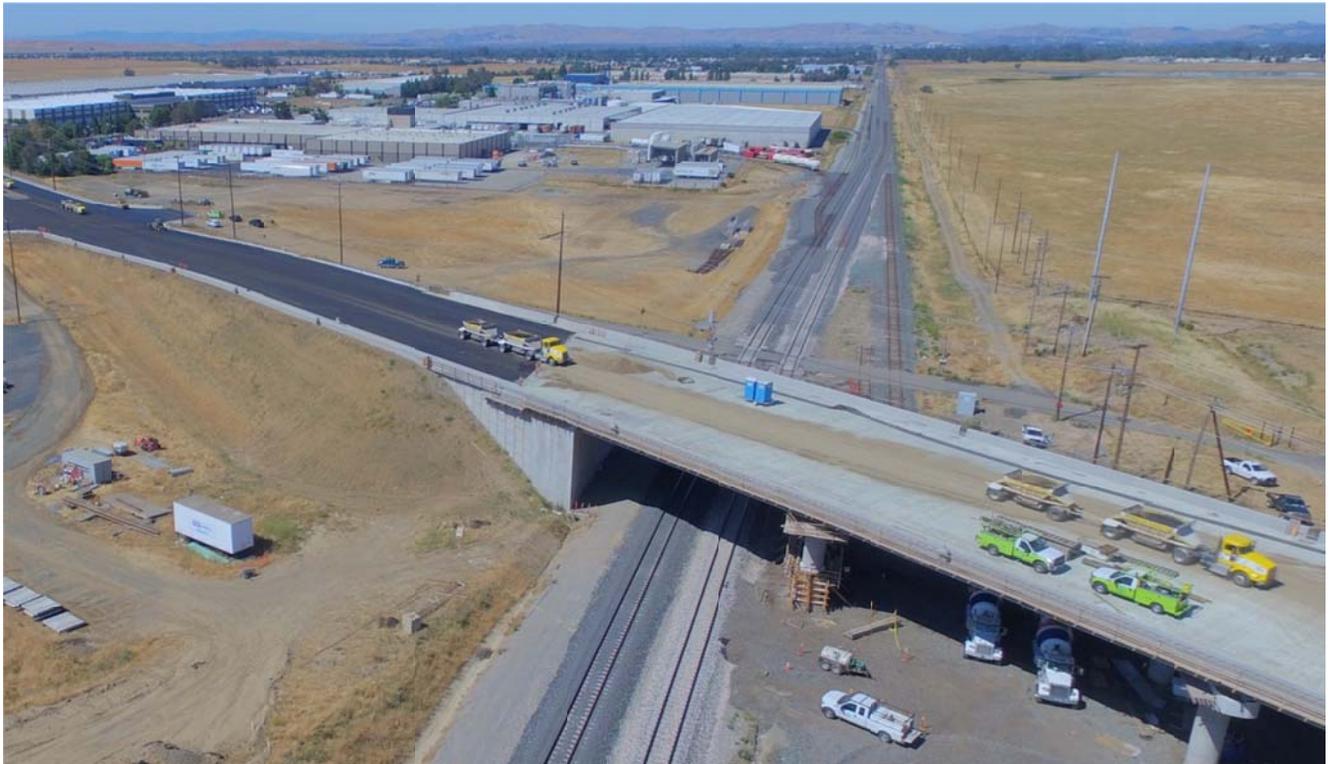
This photo displays the south portion of the overpass, facing west. Over the past month, the contractor was able to pave both ends of the overpass. The bridge deck will remain concrete.

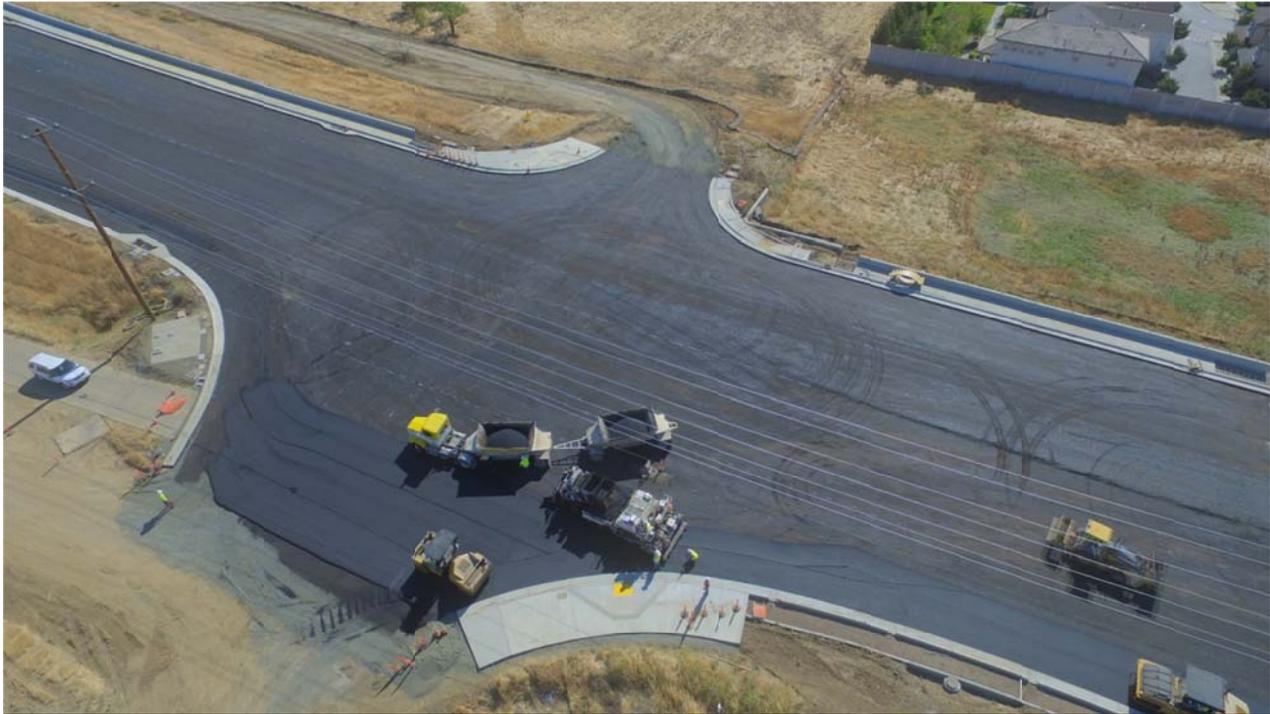
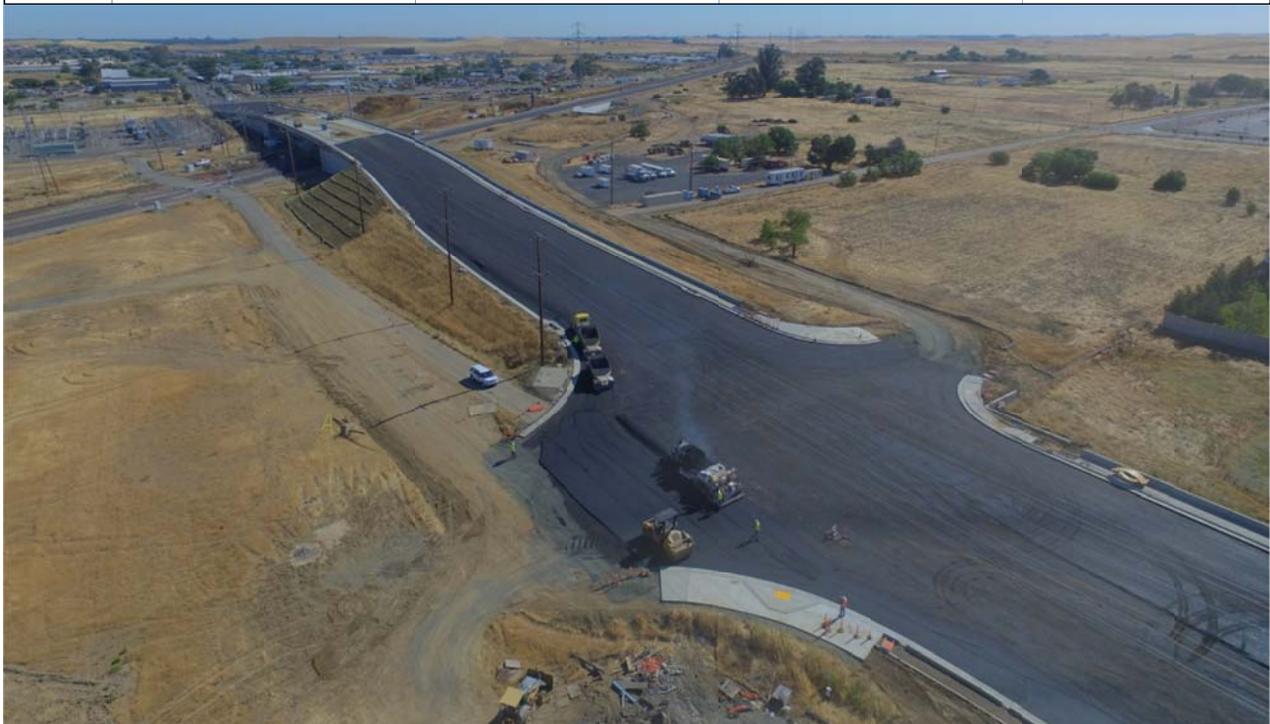
Asphalt crews were working hard to lay down asphalt on the two roadways leading up to the bridge deck. These aerial photos show the south end of the overpass, facing north.

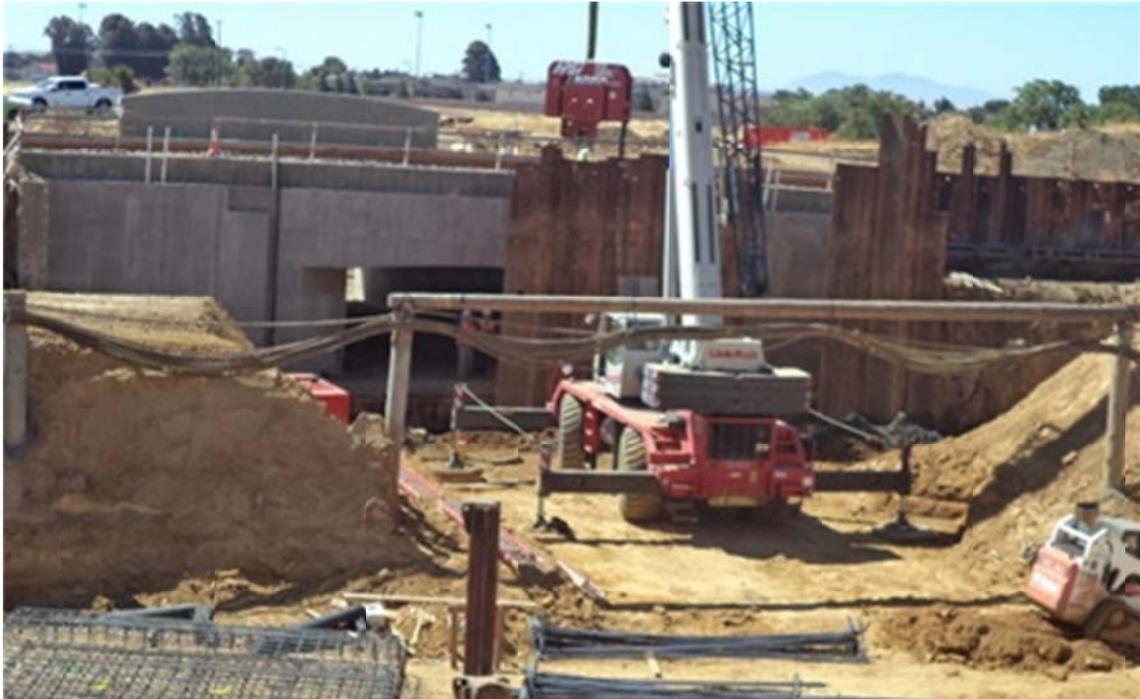
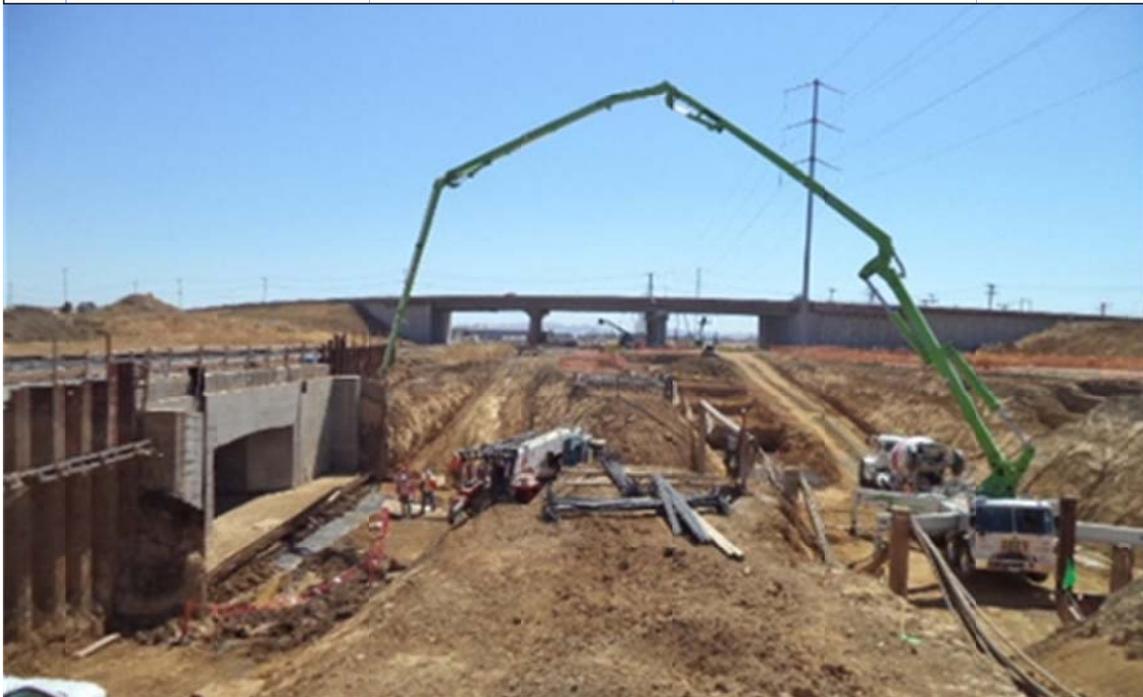
The photo above displays the unveiling of the pedestrian underpass. This was taken from the north portal excavation site, east of the Peabody overpass. The bottom photo shows the completely uncovered entrance of the north portal.

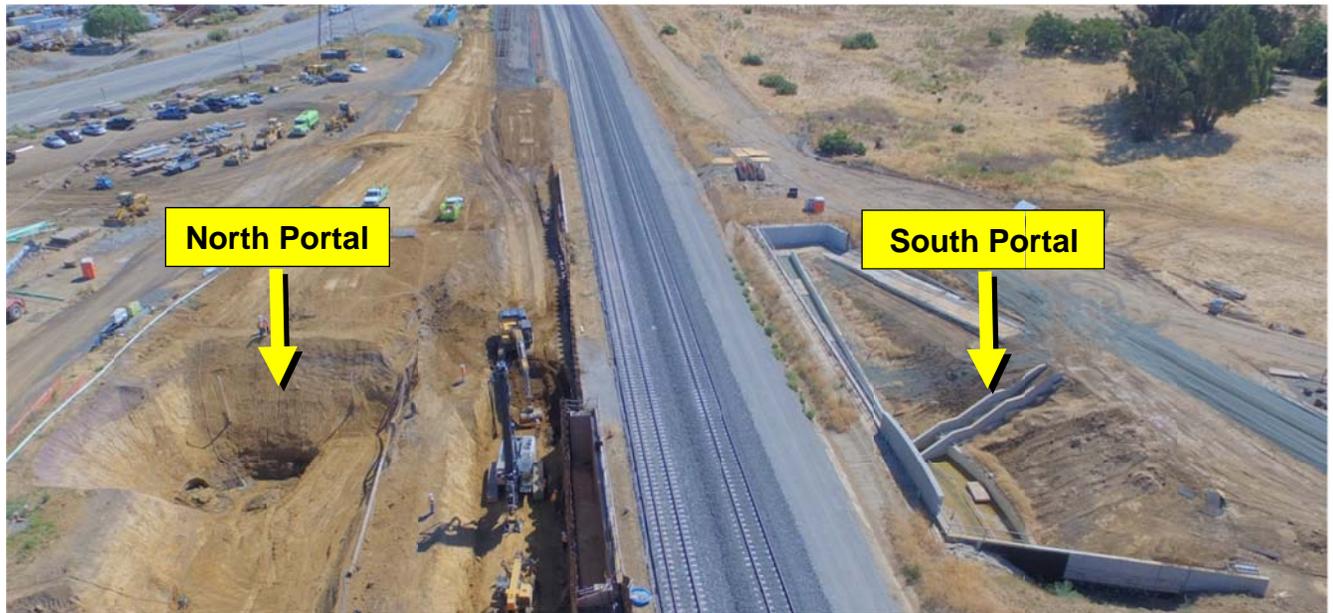
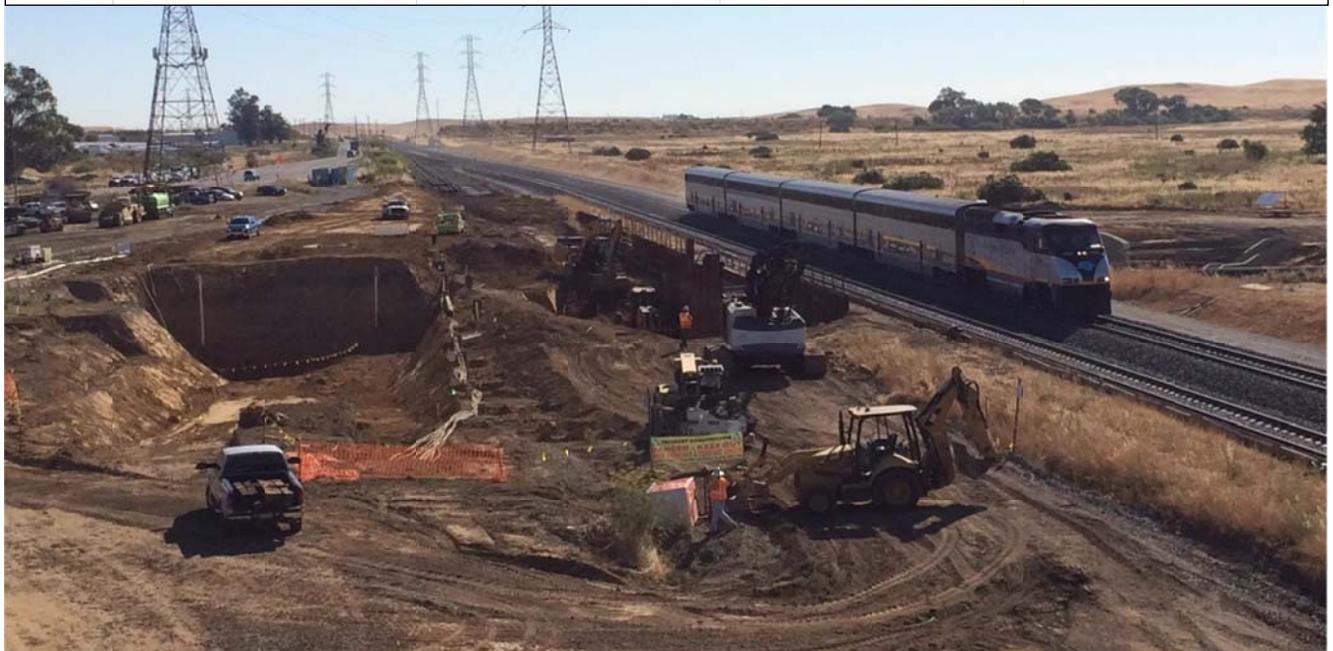
The above photo displays the north and south portals located on the east side of the overpass. The photo below, which is looking east towards Vanden Road, shows the north portal being excavated. The north portal will connect to the south portal underneath the railroad tracks through the pedestrian underpass, right where the train is in this picture!

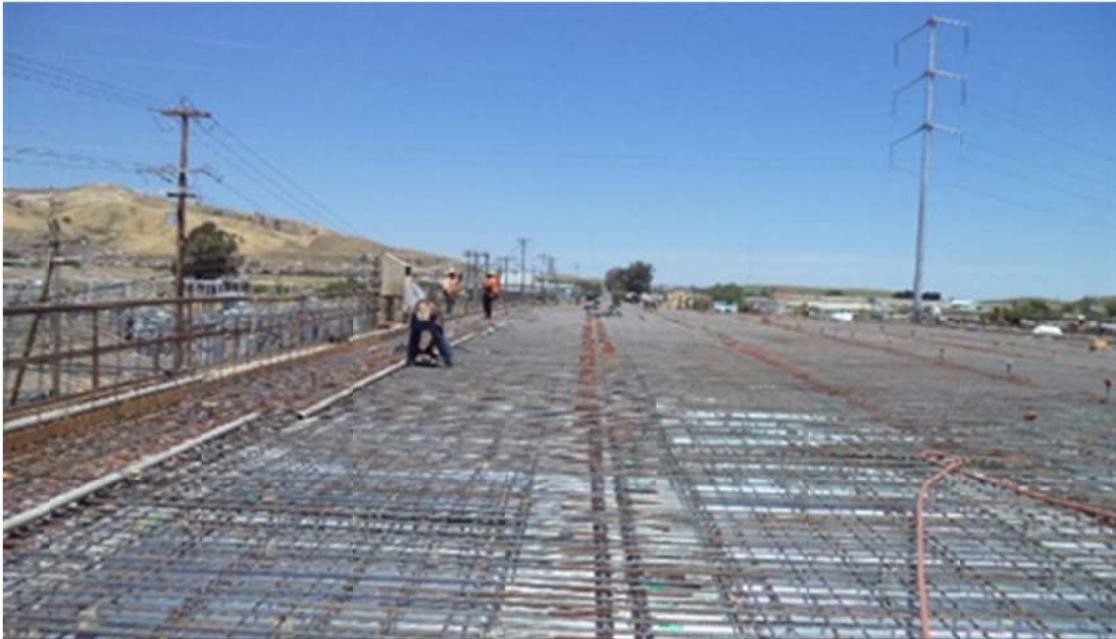
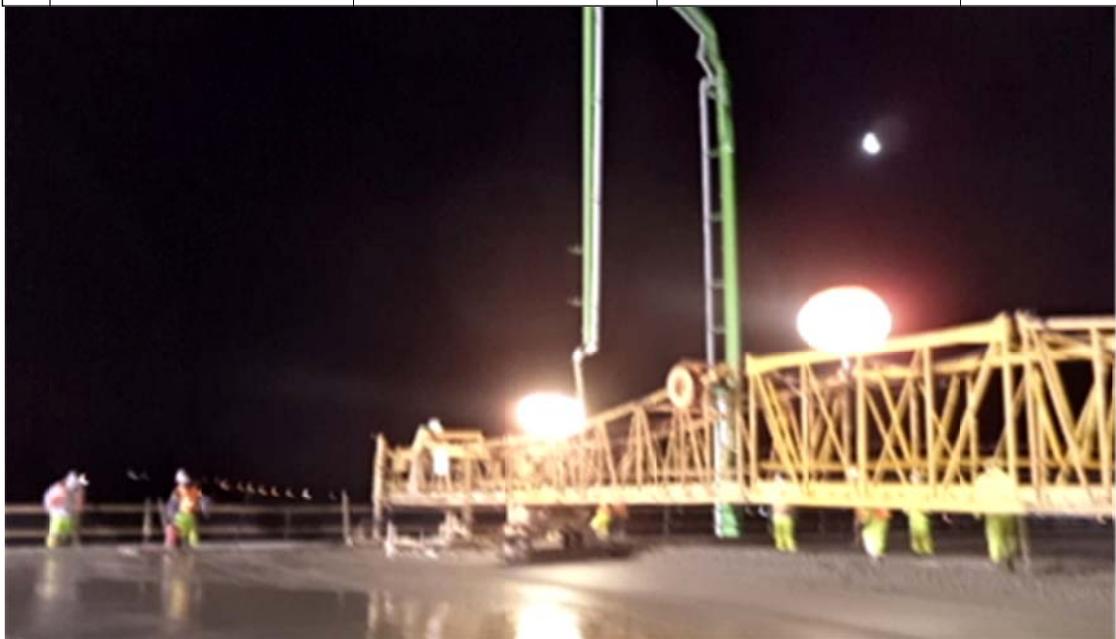
The photo above, which was taken on top of the bridge deck facing north, shows workers installing steel rebar. Once rebar was put down, they could begin pouring concrete over it. The photo below shows the fresh new concrete being poured!

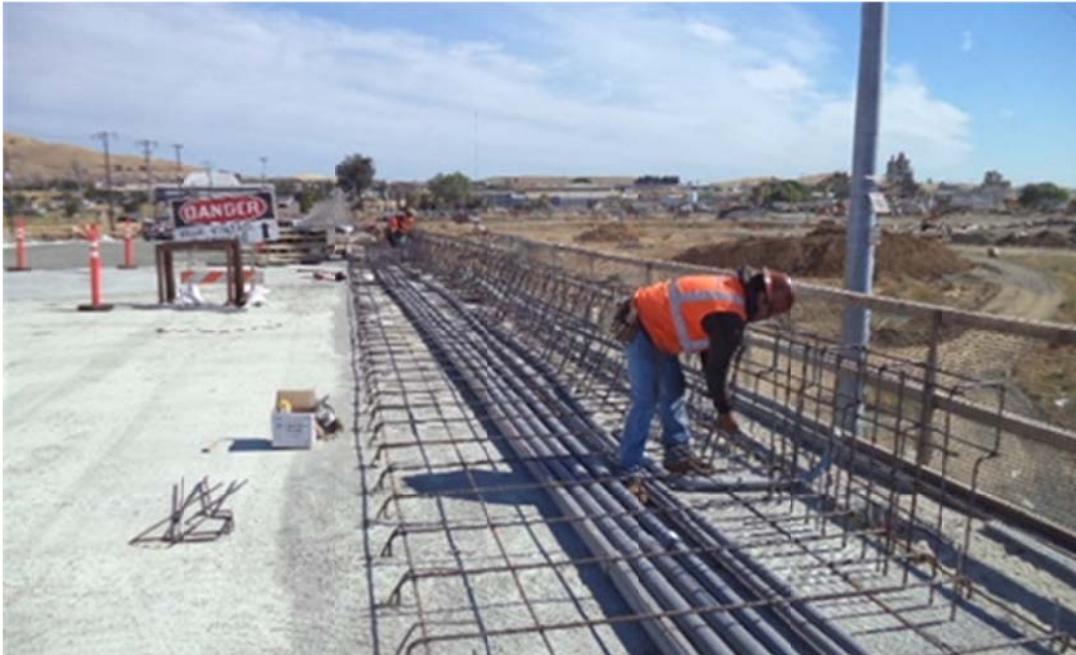
Once the deck was finished, the same process was repeated for the sidewalk and roadway barrier. The photo above, which was taken on the new concrete bridge deck facing north, shows the rebar being installed.

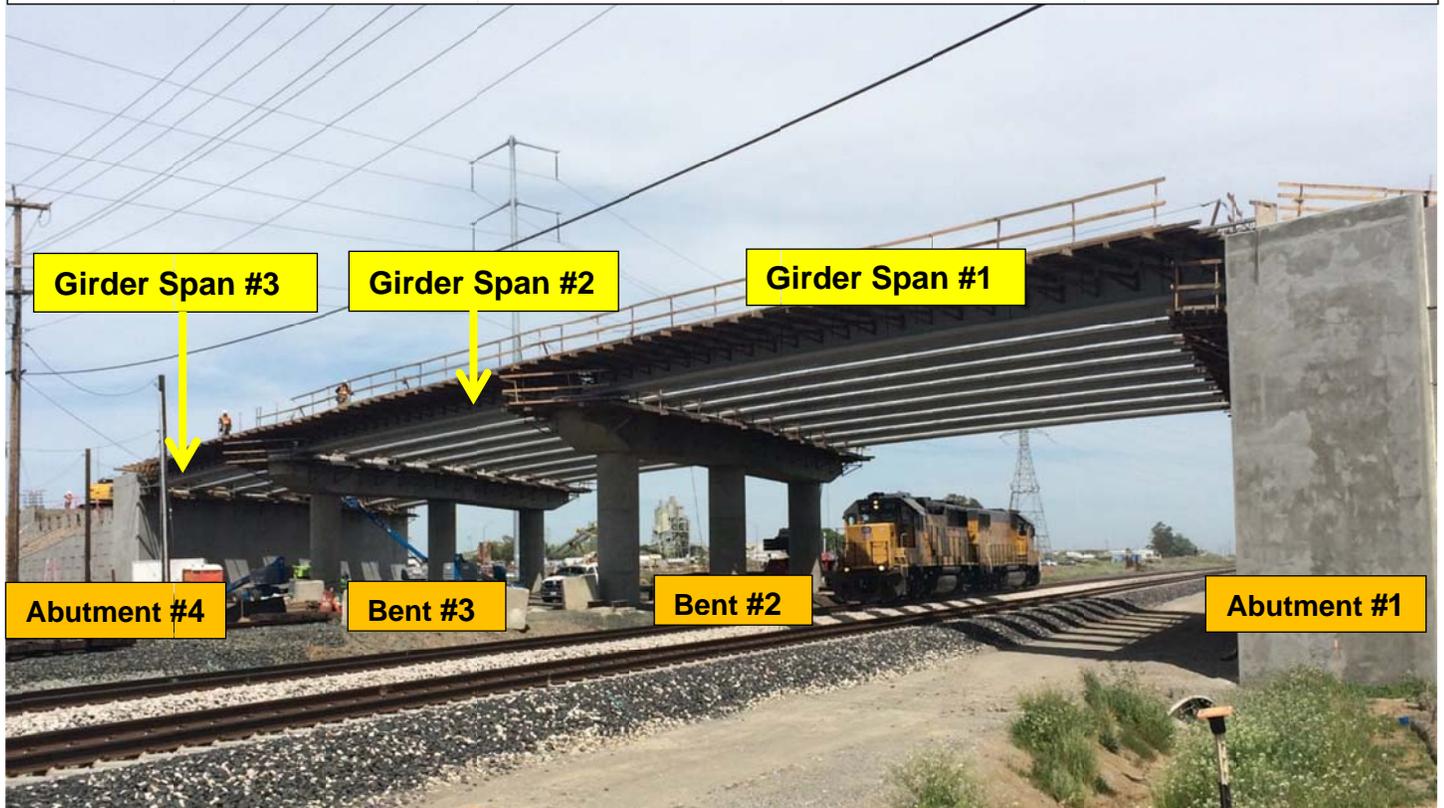
Photo below, taken on the west-side of Peabody Road looking north-east, displays the completion of the bridge girder installation. The different components of the Peabody Overpass are labeled and further discussed in detail in the progress photos that follow.

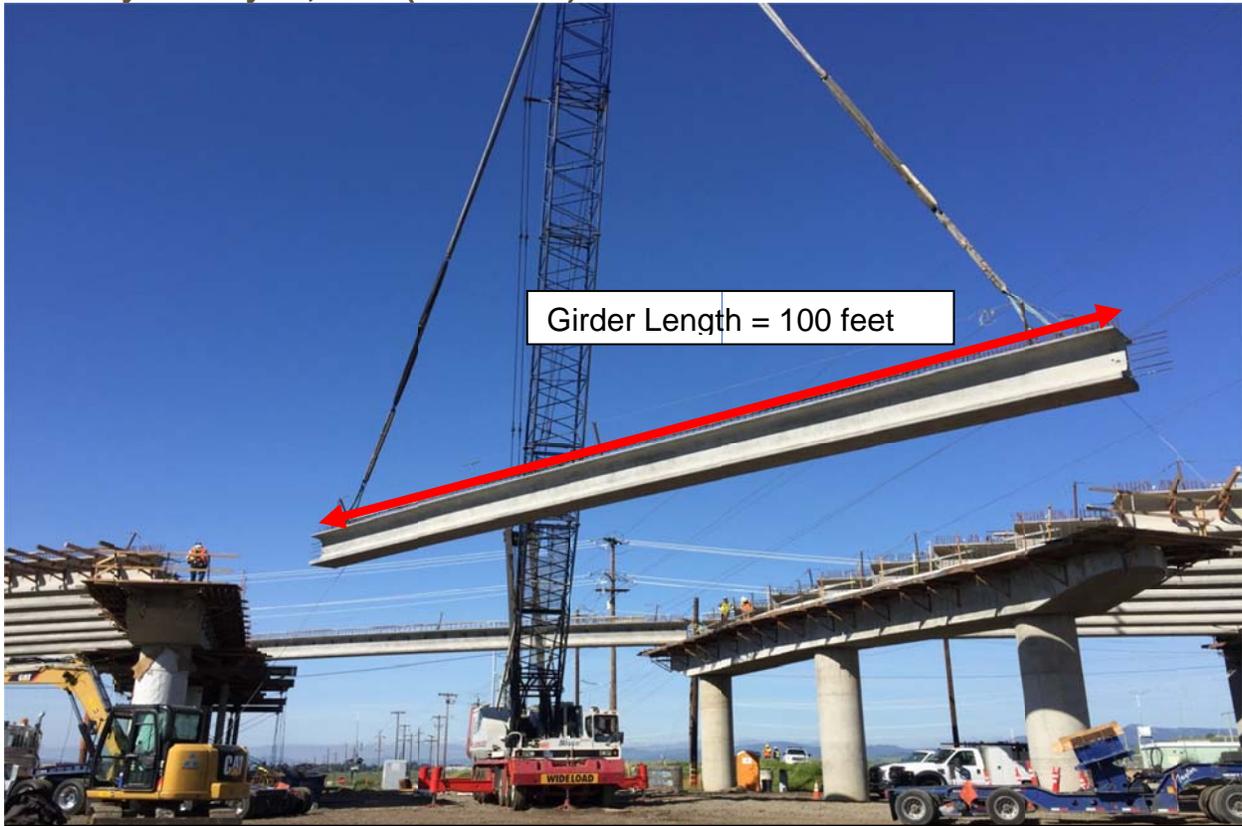
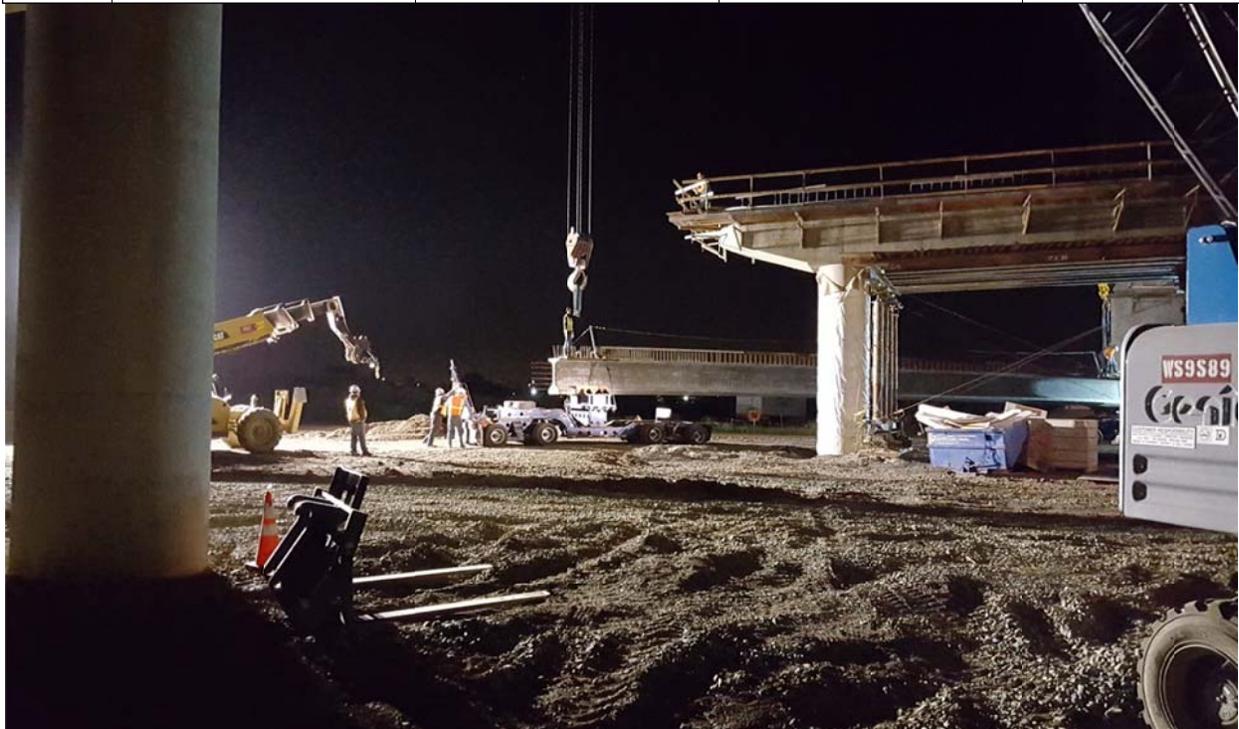
Photo above, displays the installation of the first of eight girders for Span #2. The contractor began work on Span #2 following work conducted the previous night to Span #1 (see photo below). Span #2 is over live railroad tracks and needed to be completed when there is minimal train activity.

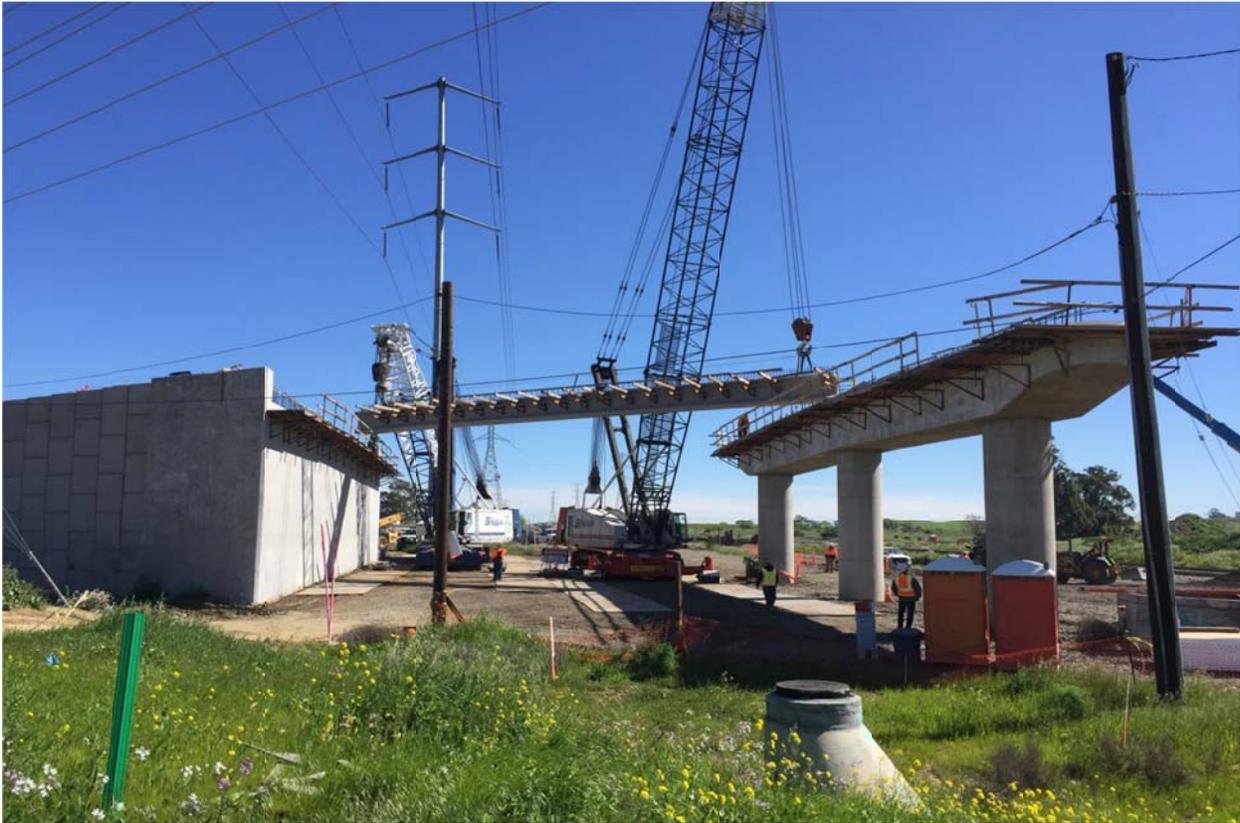
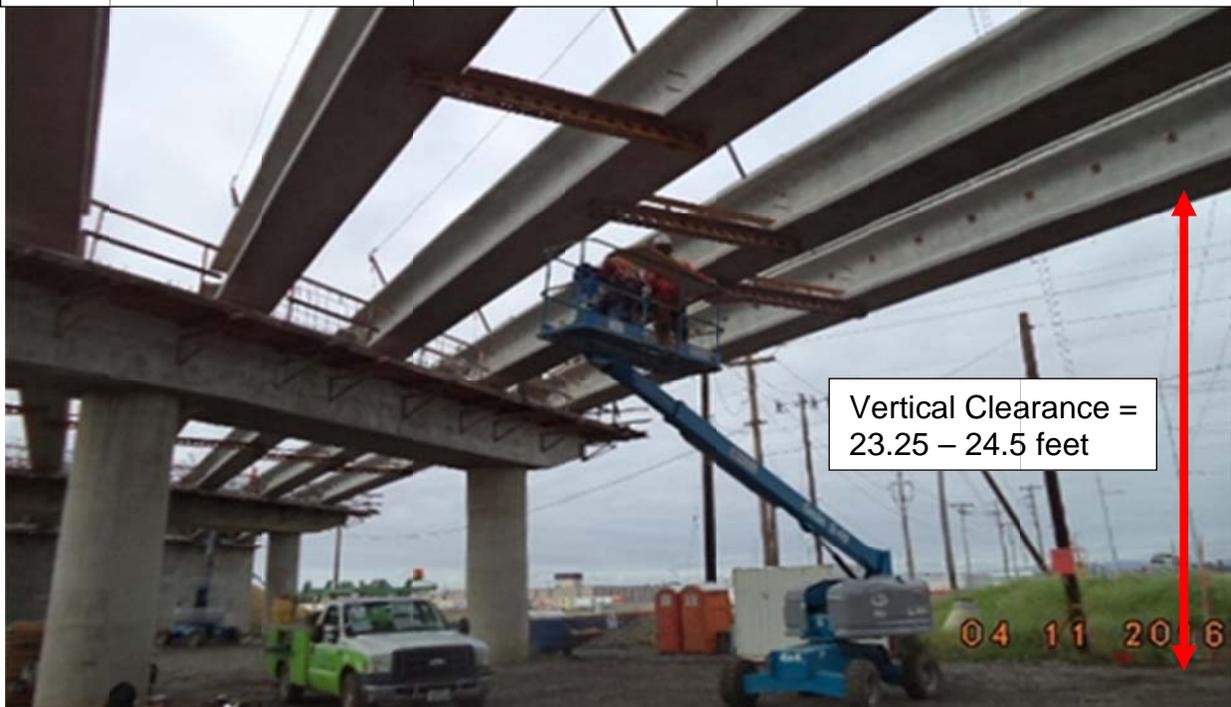
Photo, which was taken on the school buses/emergency vehicle access road looking east, displays the installation of the first girder on the project. Photo below displays the contractor installing the support bracing between the bridge girders.

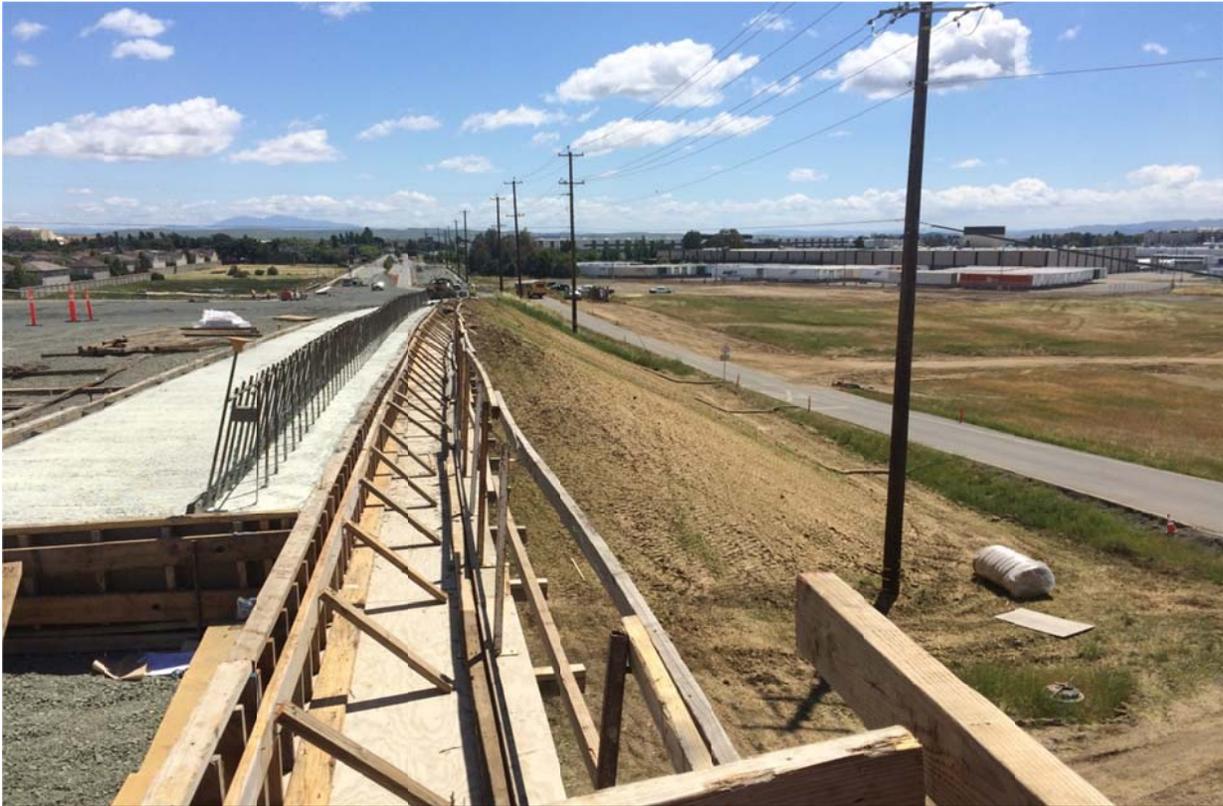
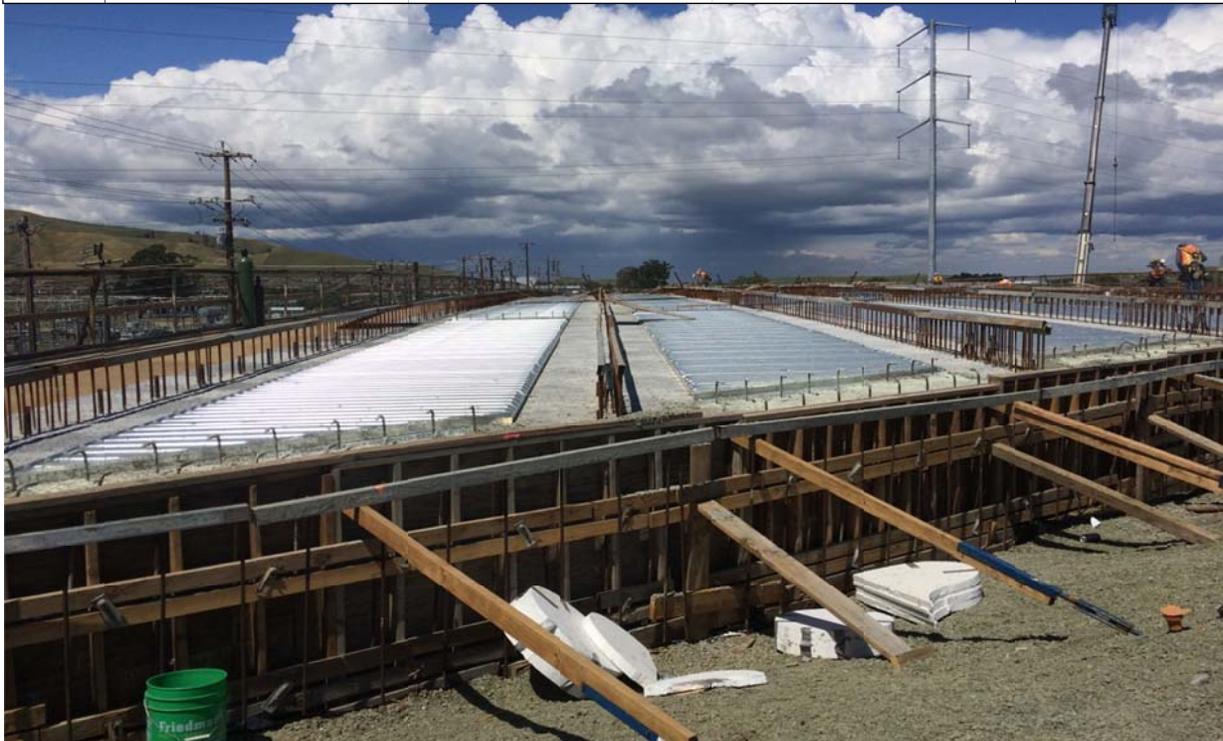
Photo above, which was taken on top of the Peabody Overpass looking south, shows the embankment and the contractor installing the roadway barrier. Photo below is of Span #1 and displays the steel decking that connects the bridge girders.

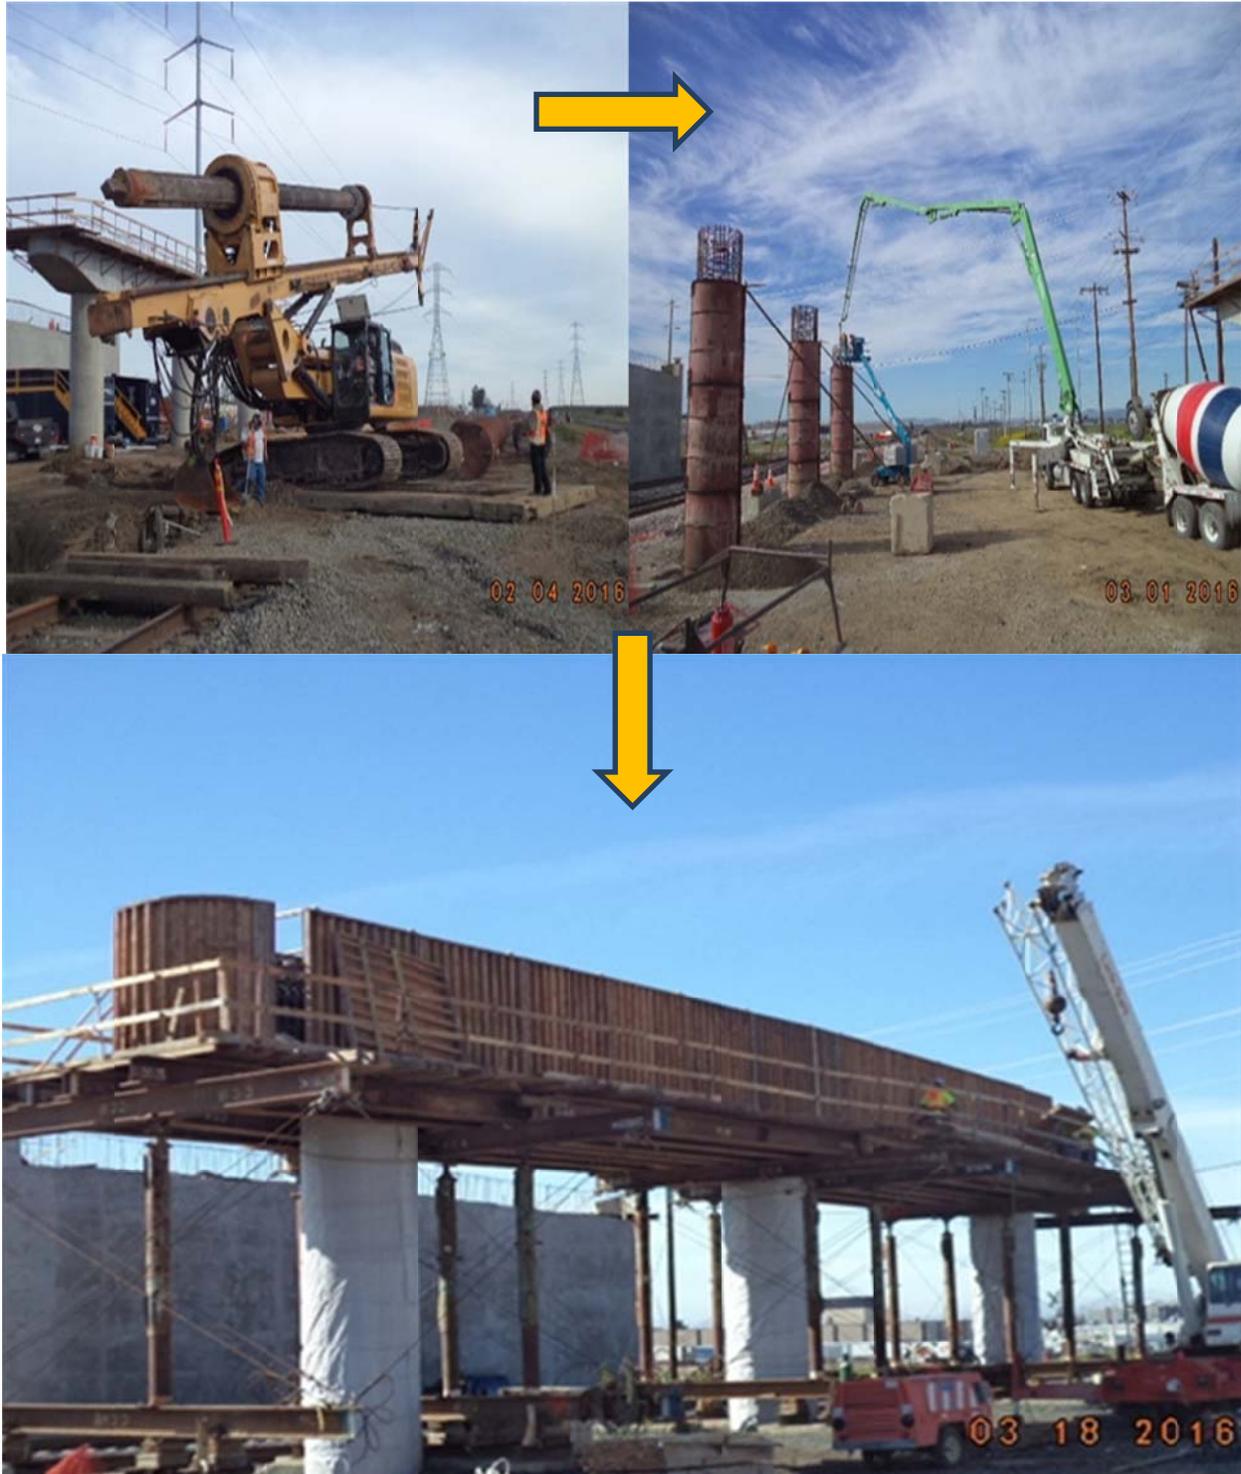
Progression photos of the Contractor completing work on Bent #2. Upper left displays the foundation for the 72" columns being completed. Upper right shows the rebar reinforcing for the three columns prior to the concrete. The final photo displays the bent cap being formed and reinforced with steel.

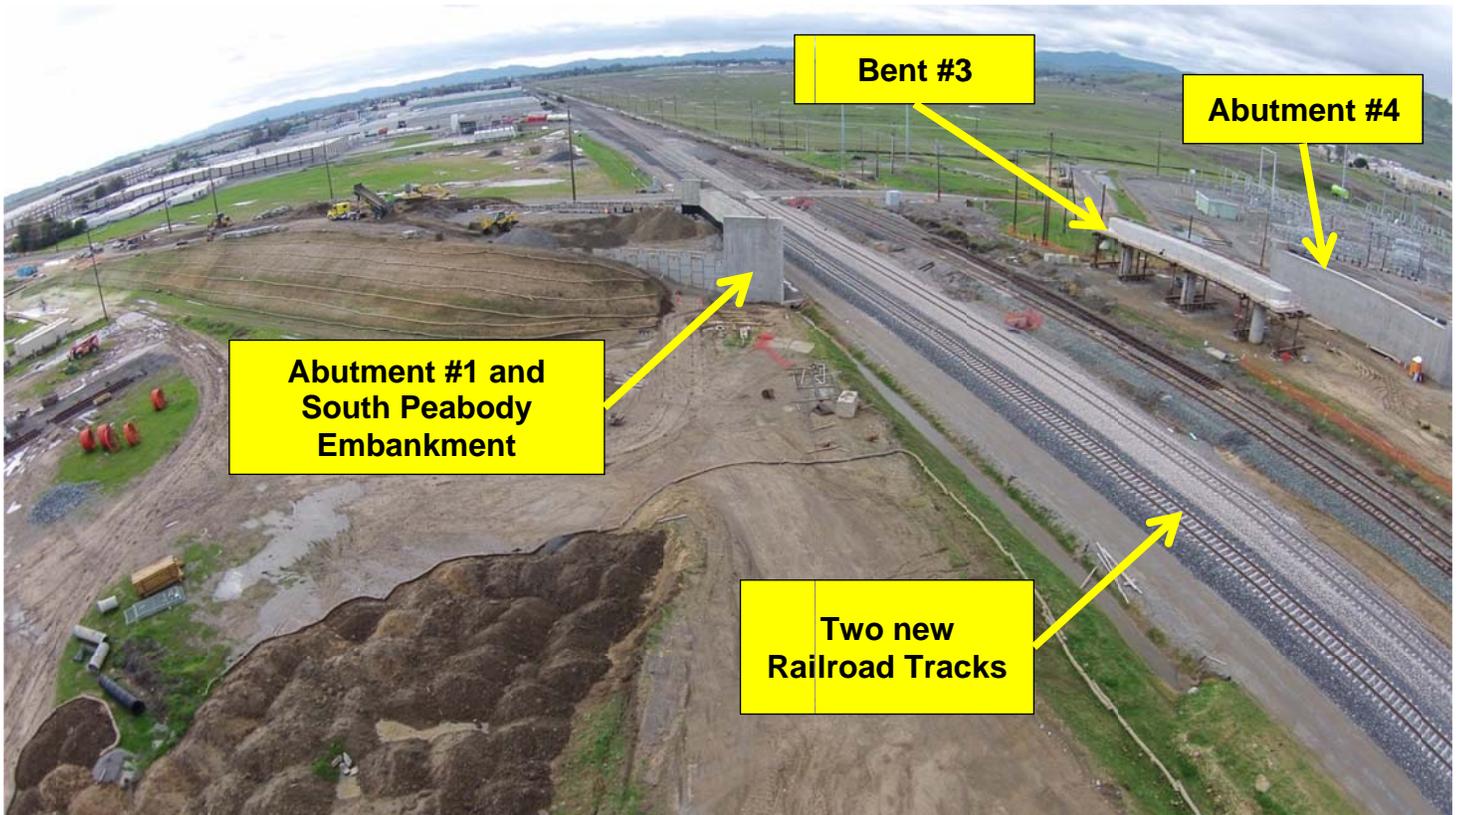
Union Pacific Railroad has completed the installation of the second set of tracks and trains are now running. This marks a major milestone in the project as the contractor will soon start the removal of the two (2) existing tracks and work on the foundation for Bent 2. **Also please see the [City webpage for additional project construction aerial images.](#)**

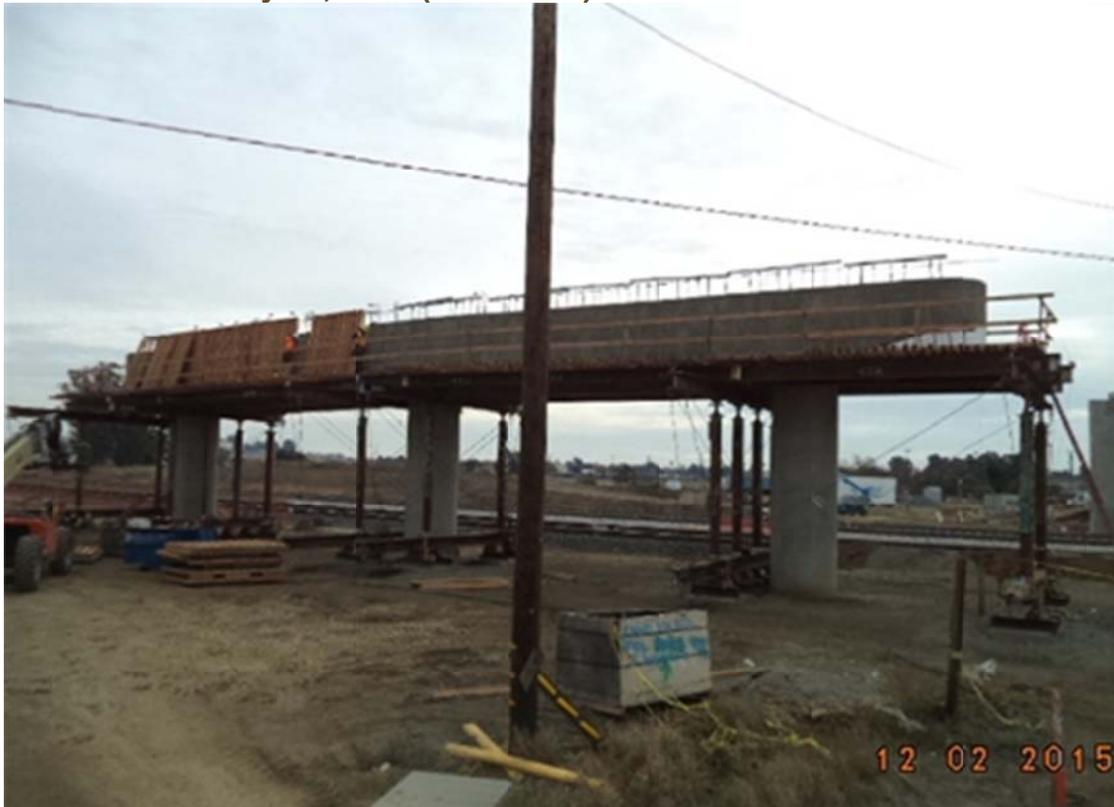
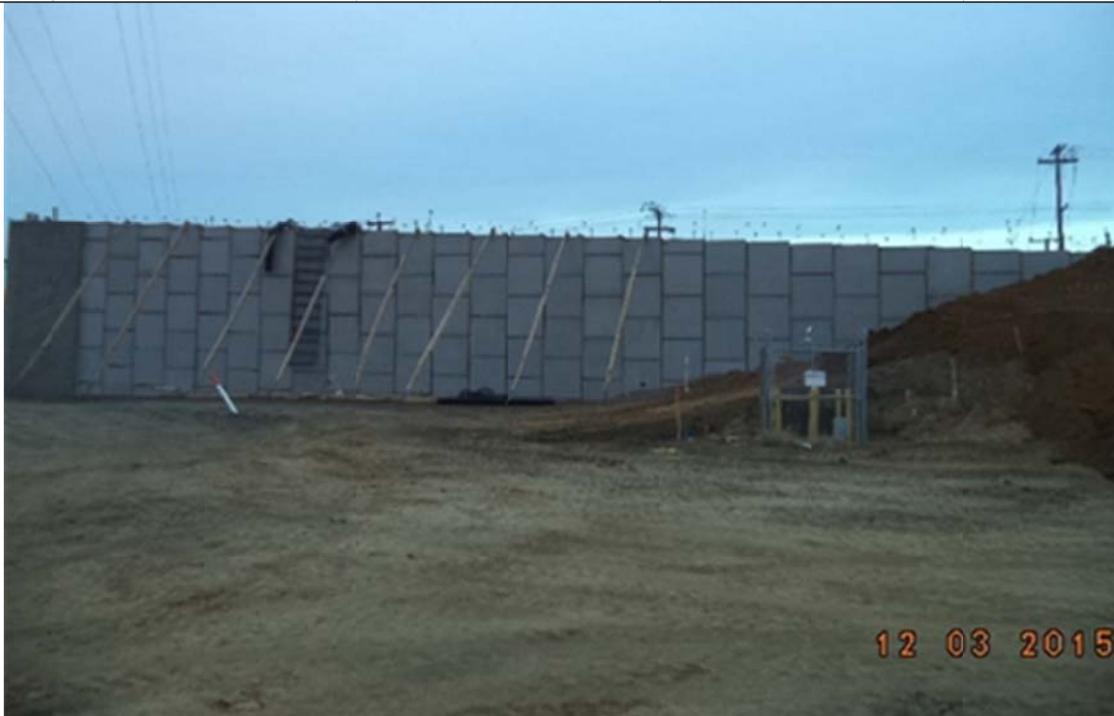
Photo above displays the contractor removing the forms from the false work of Bent #3. Below shows the last panel has been installed for the MSE wall located on the east side of Abutment #4.

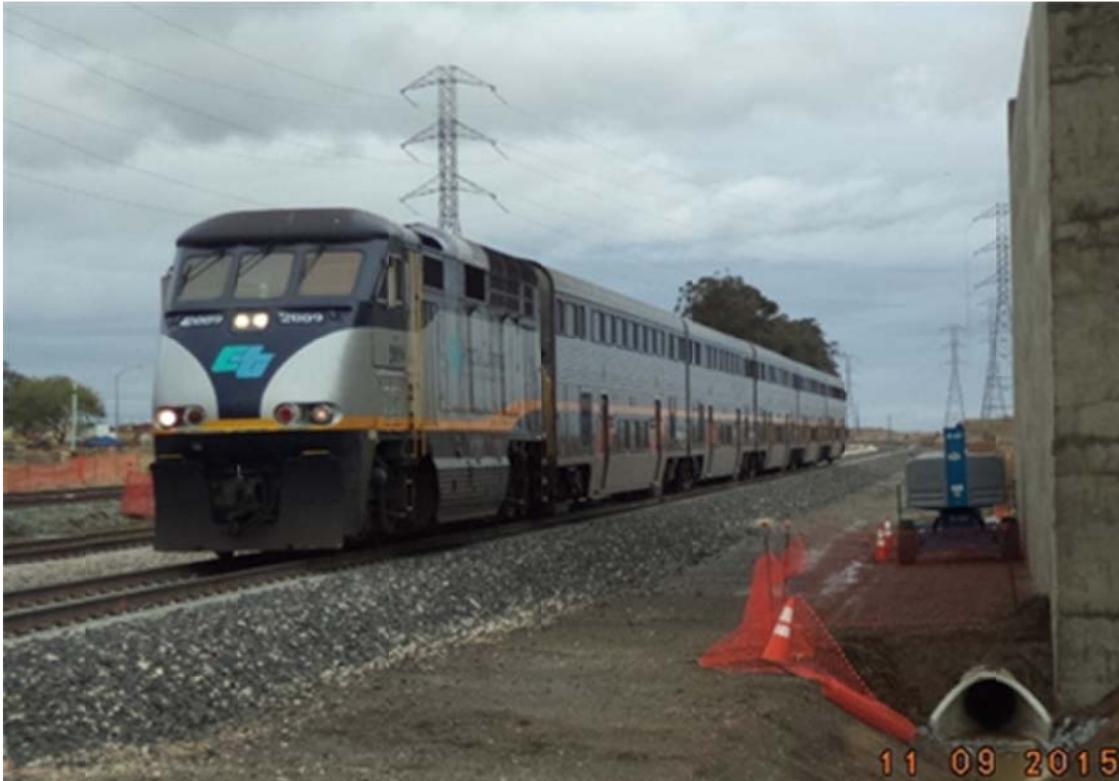
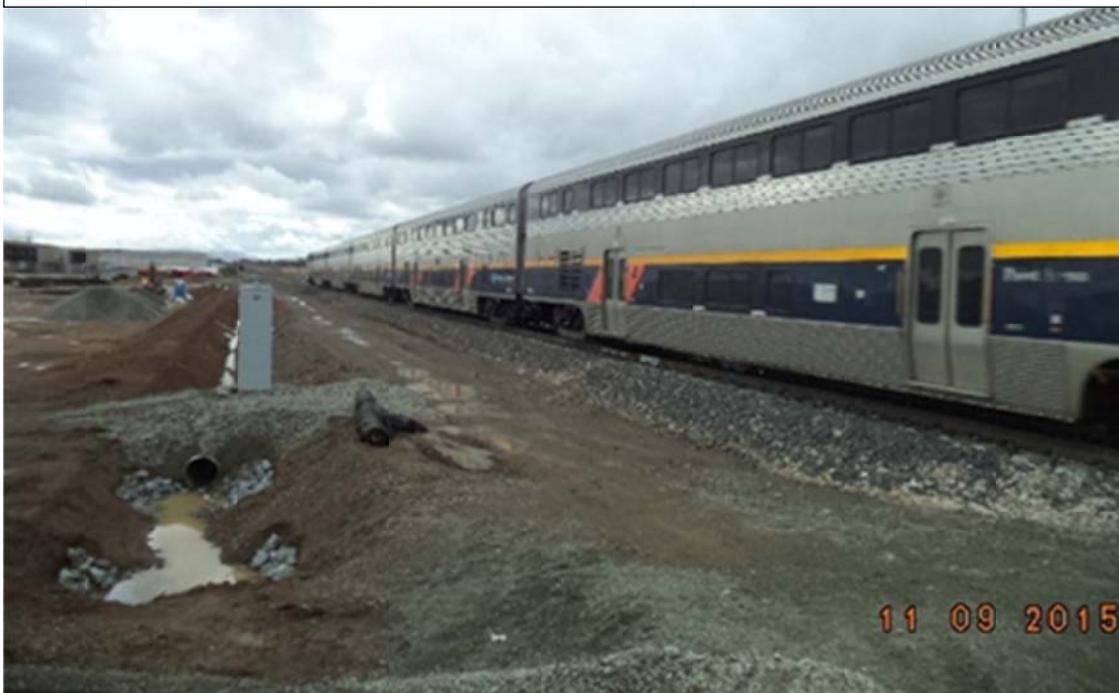
**GREAT NEWS!!!** Union Pacific Rail Road has completed the installation of 1 of 2 new railroad tracks within the vicinity of the Train Station site. As these two photos display (top looking east, bottom looking west) Capitol Corridor is now running trains on the recently completed tracks.
