## Fairfield / Vacaville Train Station and Peabody Road Improvements

### Current Construction Status (UPDATED 08-10-16)

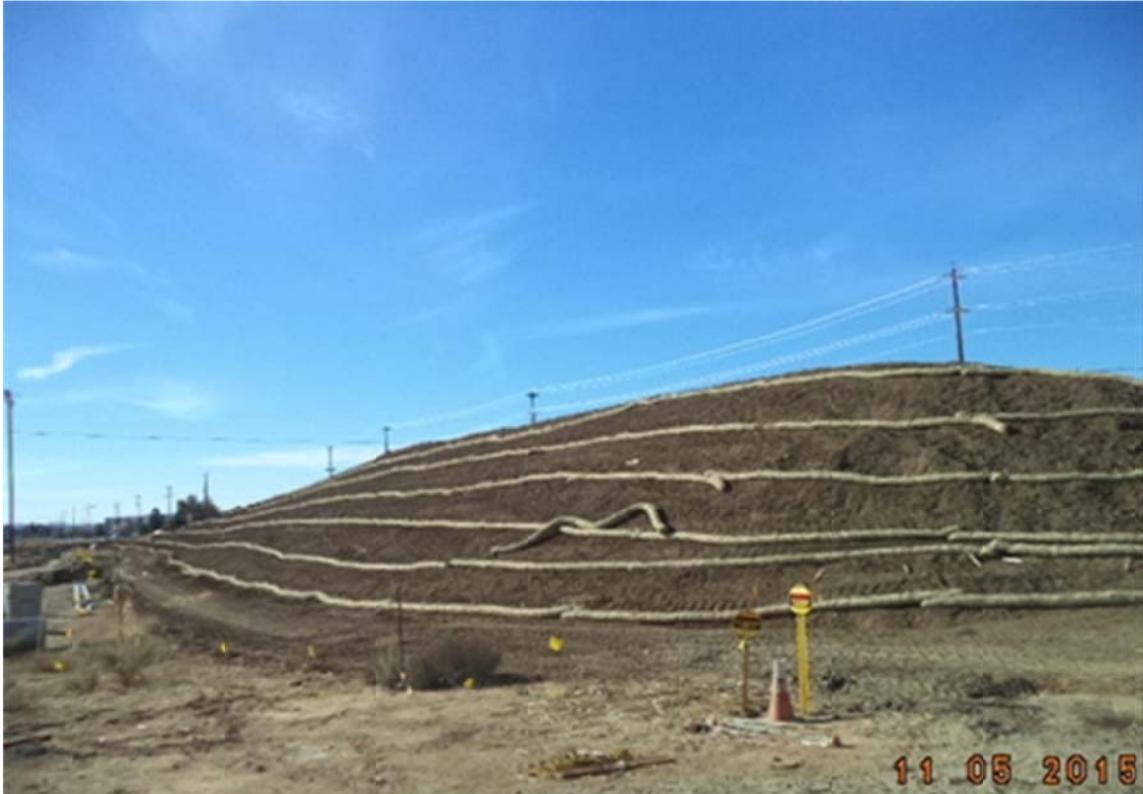
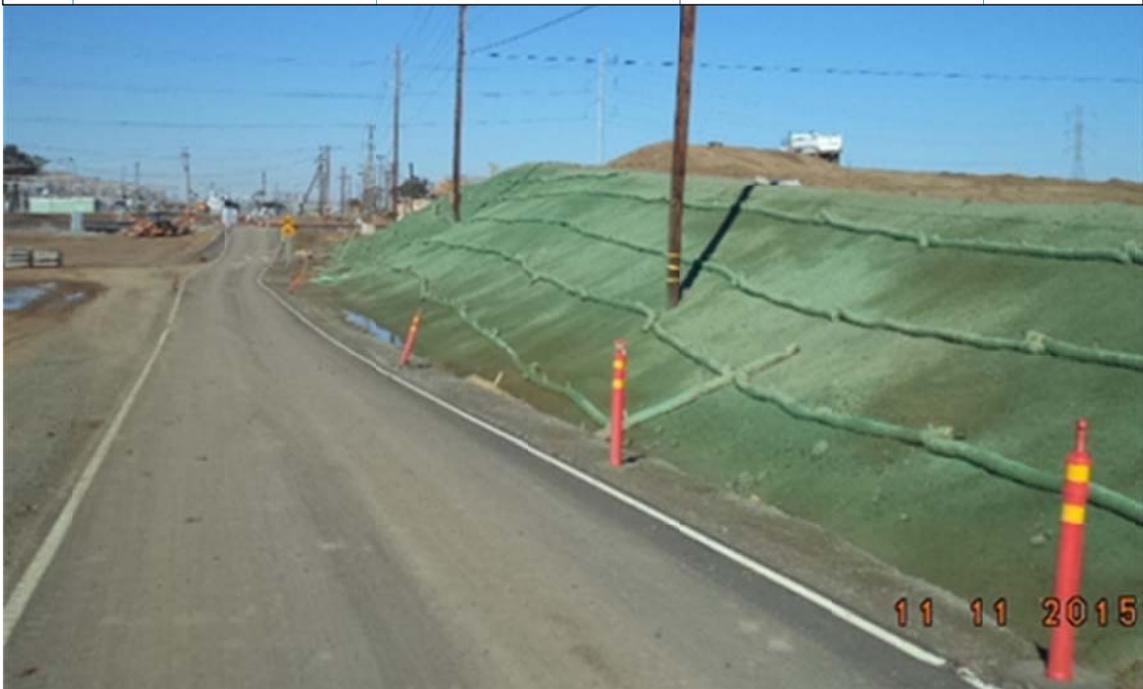
In preparation for the [upcoming winter](#), the contractor has installed the erosion and sediment control measures on the recently constructed Peabody Overpass Embankments. Both photos are of the southern approach (top looking east and bottom is taken on the EVA/School Bus route looking west).

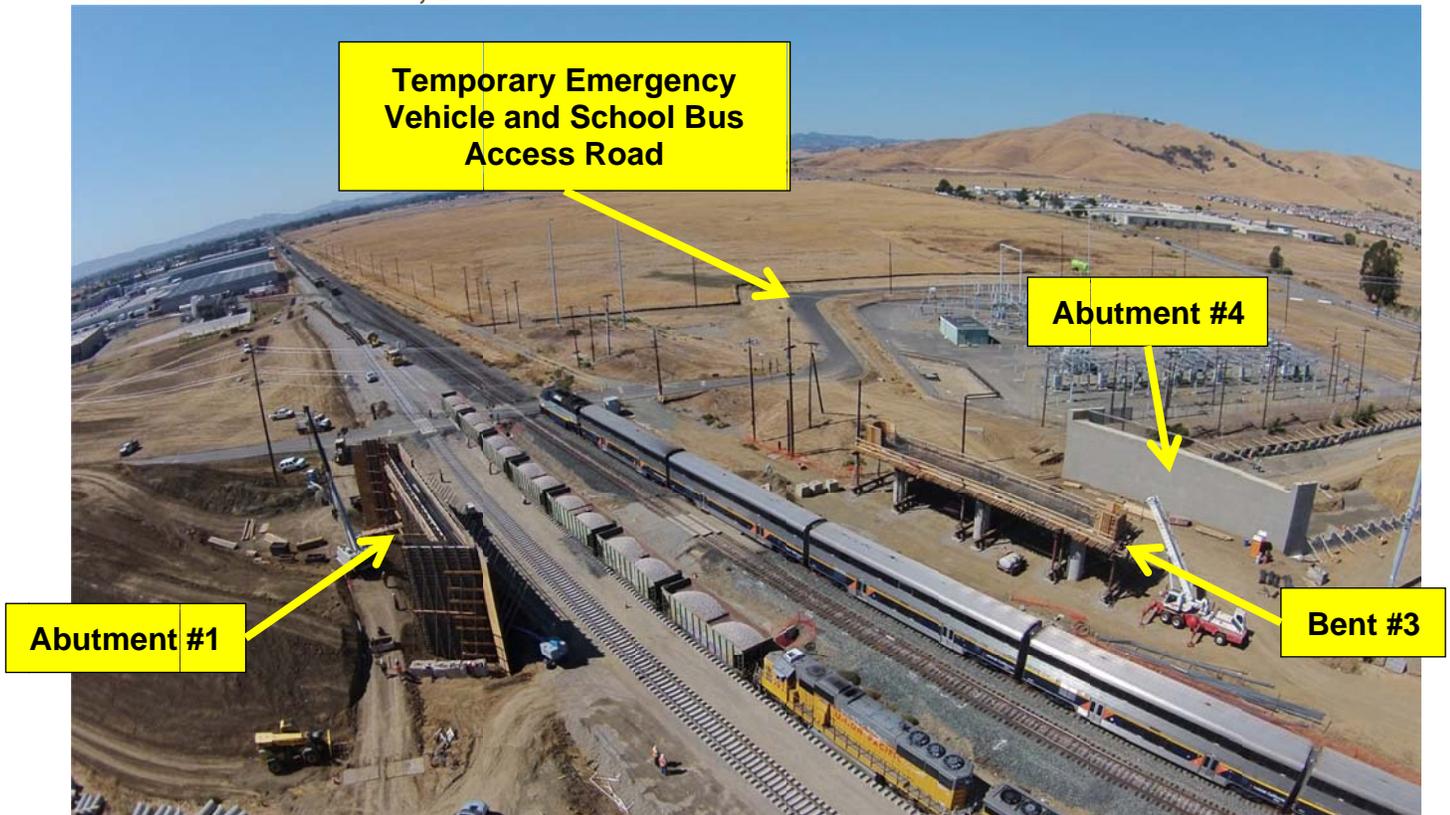
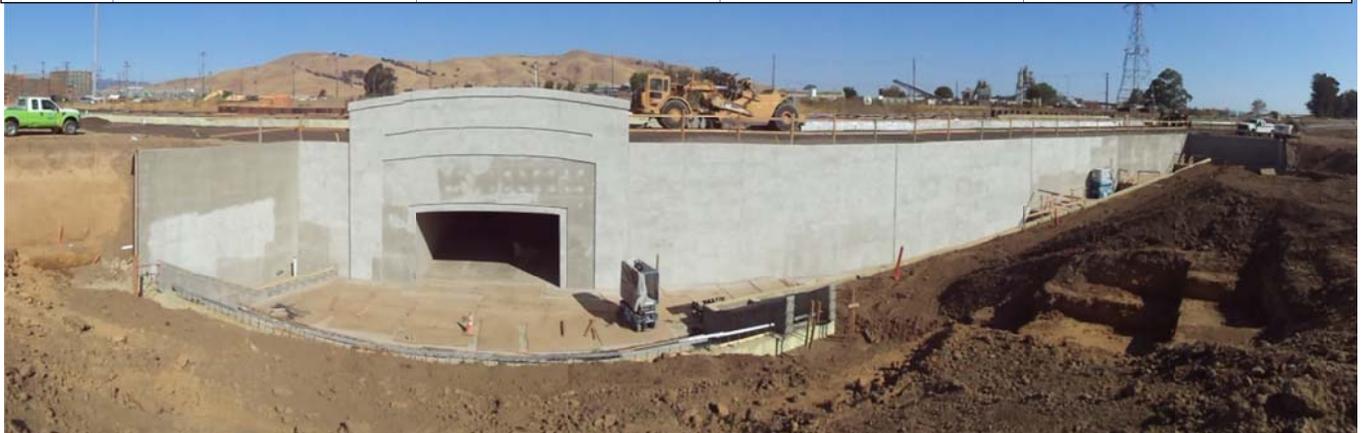
Photo above is an overhead view of the construction progress on the Peabody Overpass and displays the alignment of the Temporary Emergency Vehicle and School Bus Access Road. Photo below is a panoramic view of the South Portal. **Also please see the [City webpage](#) for additional project construction aerial images.**

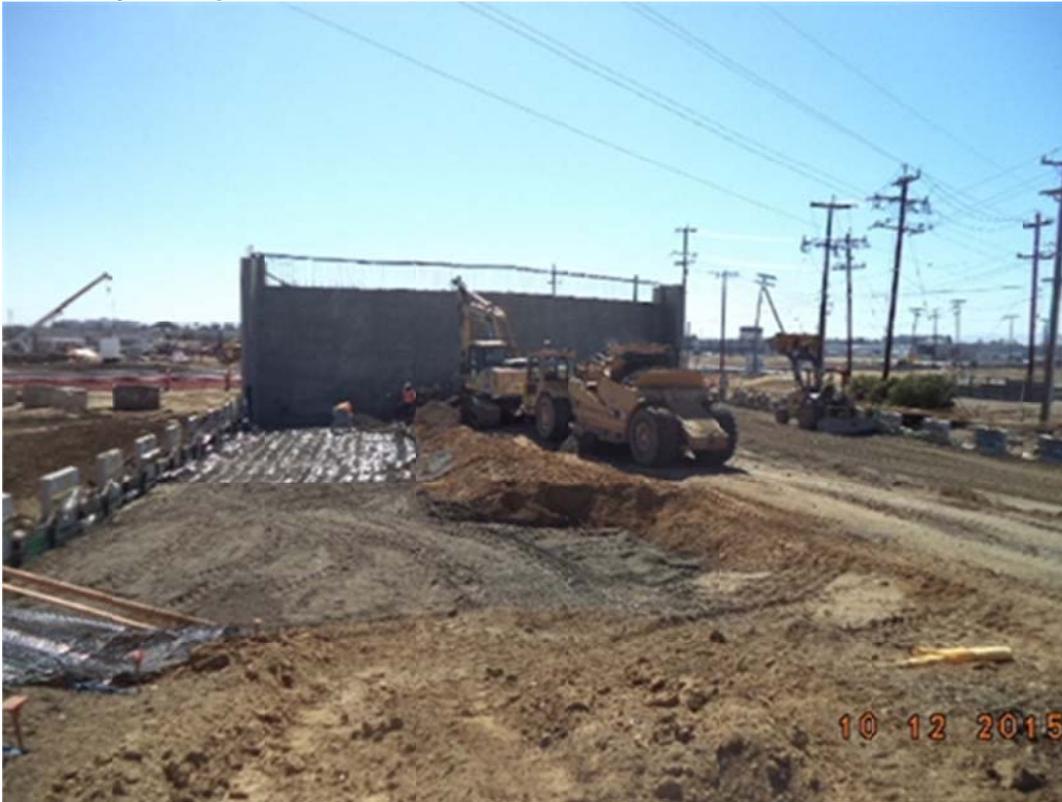
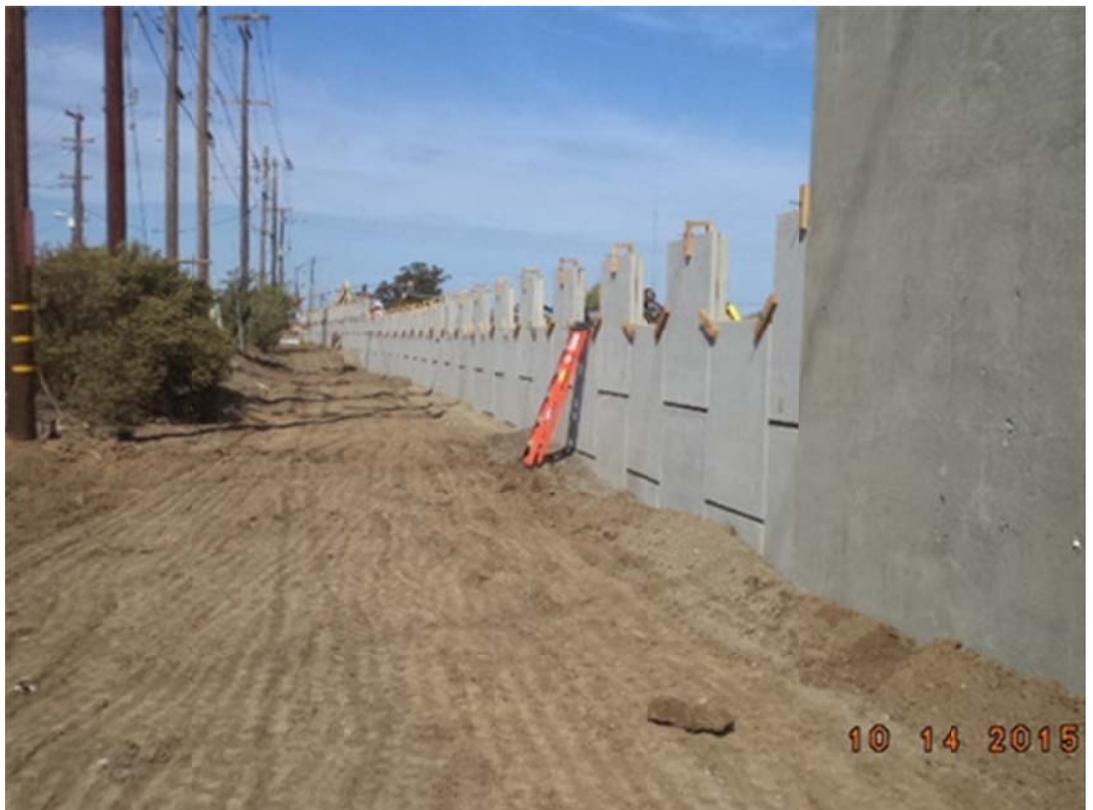
Photo at left displays the Mechanically Stabilized Earth (MSE) Walls that are installed on either side of Abutment #4.

Photo at right shows a detailed view of the MSE wall installation along the western portion of the Peabody Overpass.

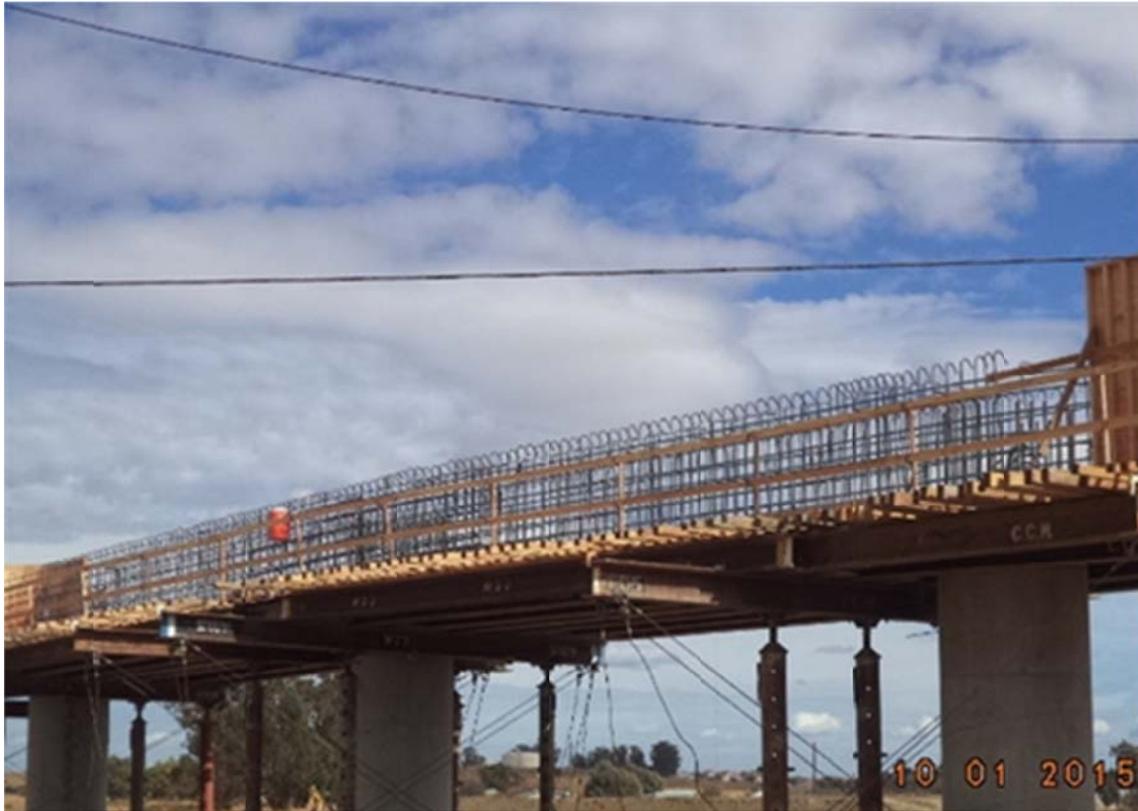
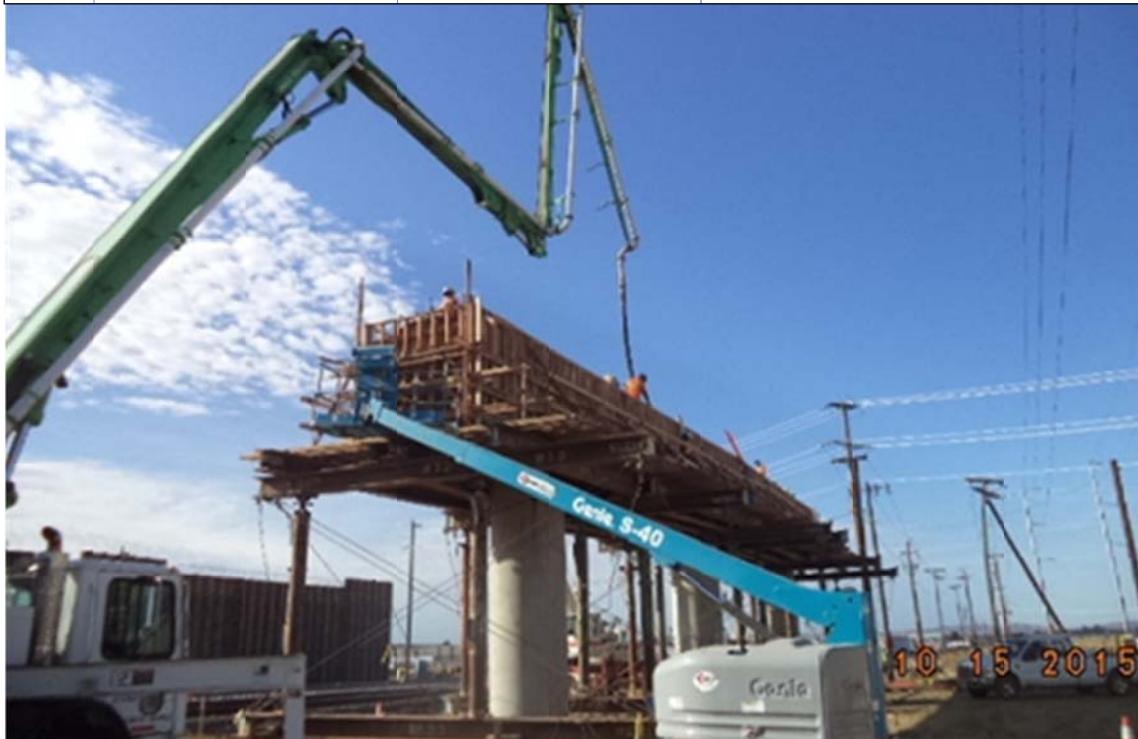
Photo above (10-01-15) displays Bent #3 cap reinforcing steel installation and photo below (10-15-15) shows the concrete placement at Bent #3.
--

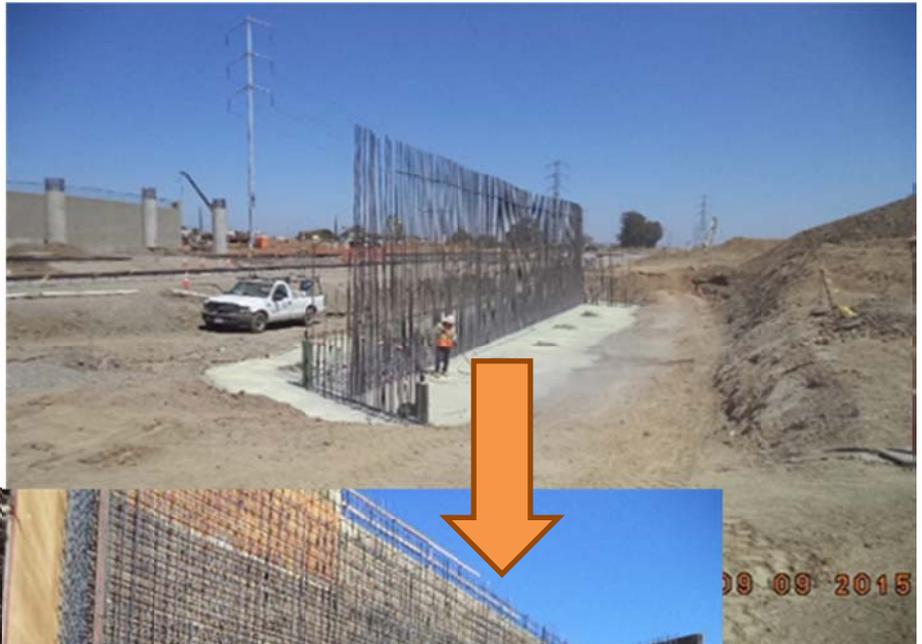
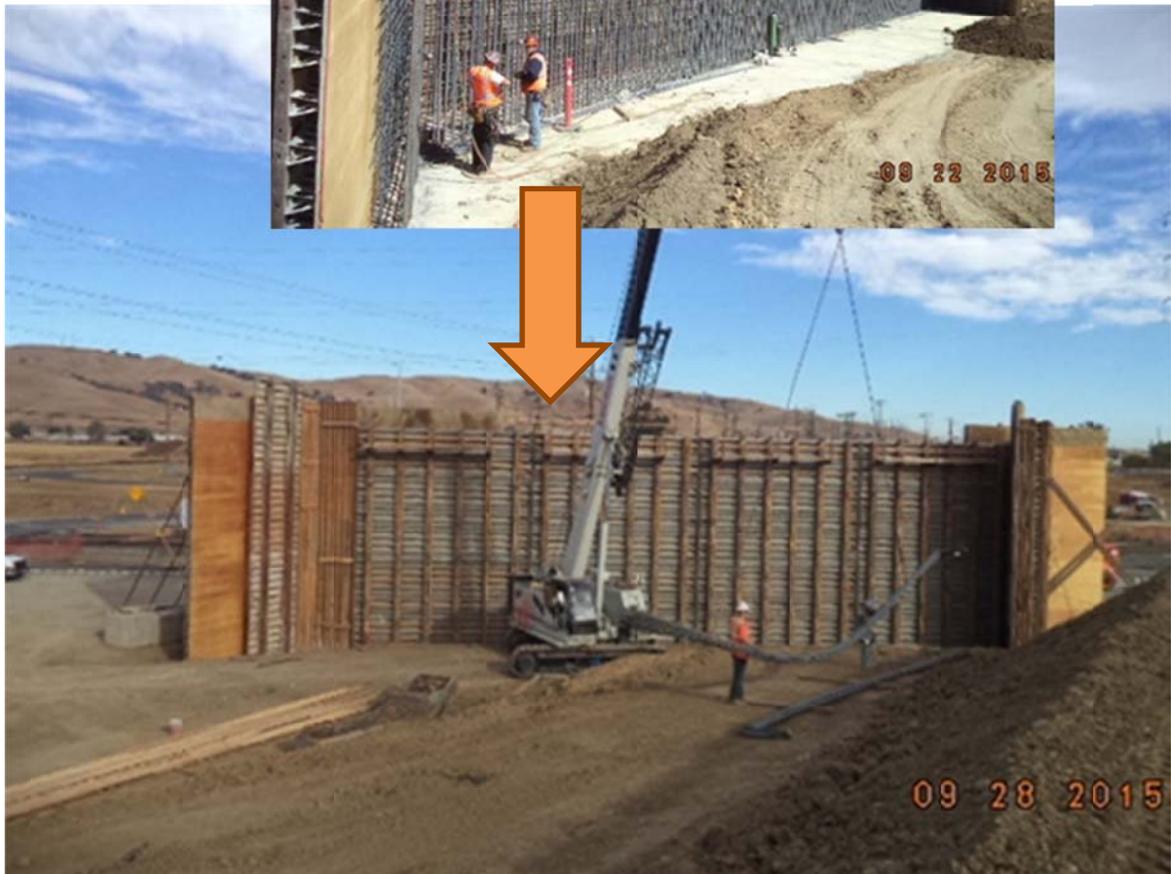
**Peabody Overpass (Abutment #1)**

Top photo (09-09-15) displays the poured concrete footing for Abutment #1 and the contractor starting work on reinforcing steel installation. Photo below (09-22-15) displays the progression of work at Abutment #1 and the bottom photo (09-28-15) displays the forms erected in preparation for a concrete pour.

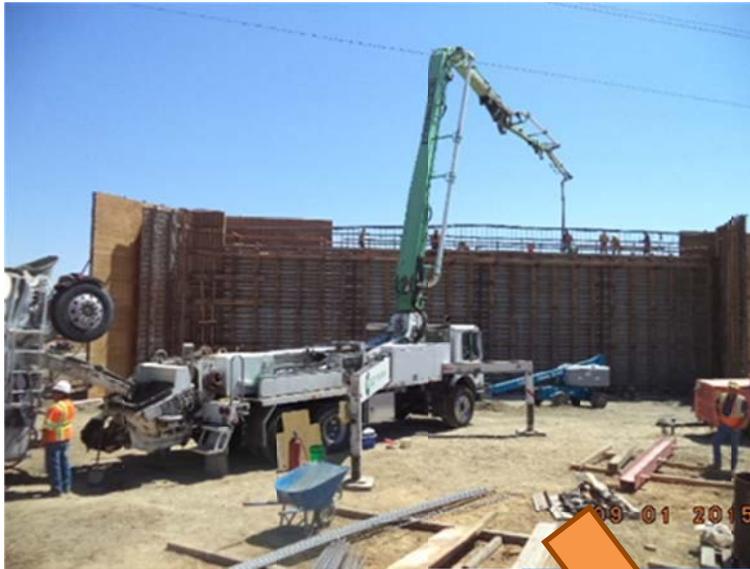
Peabody Overpass (Abutment #4)

Photos display the progression of work during the month of September on Abutment #4 located north of the railroad tracks. Top photo (9-1-15) shows concrete placement activities. The middle photo (9-8-15) displays the contractor removing the forms and the bottom photo (9-28-15) displays the contractor preparing the interface between the wing wall of the abutment and MSE walls.

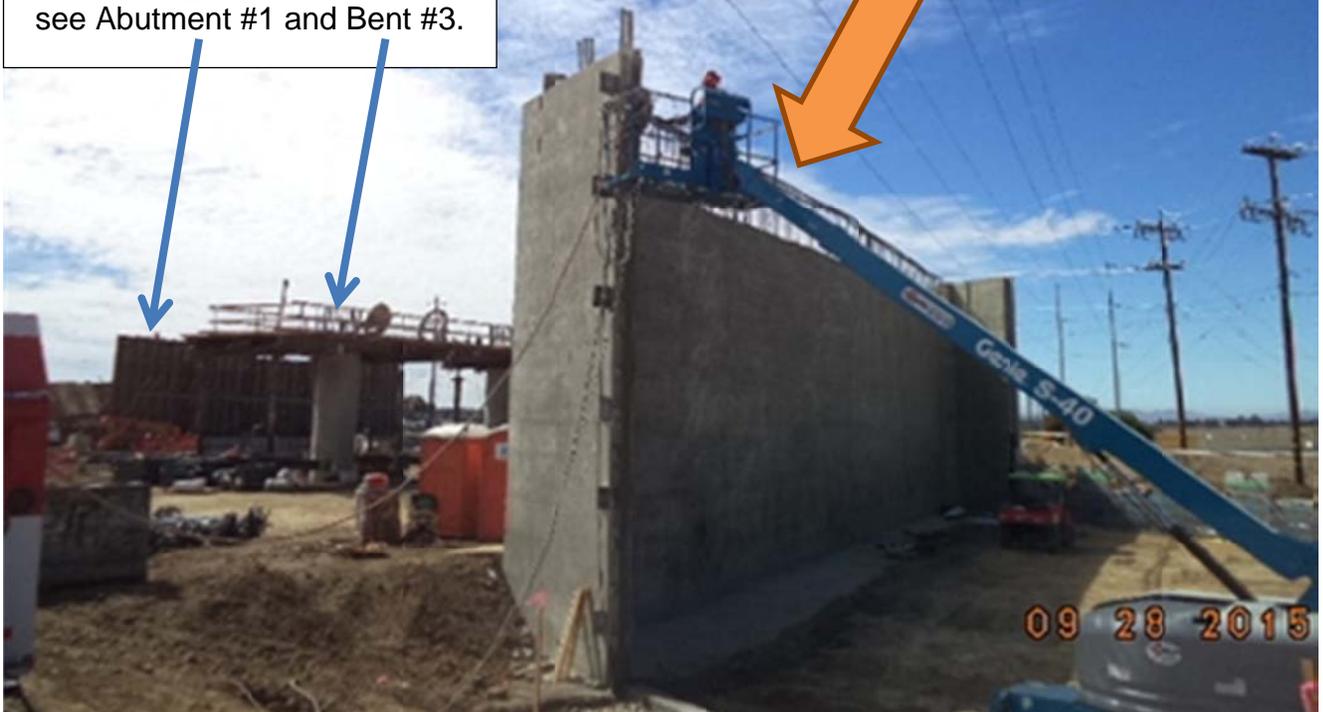
In the background you can also see Abutment #1 and Bent #3.

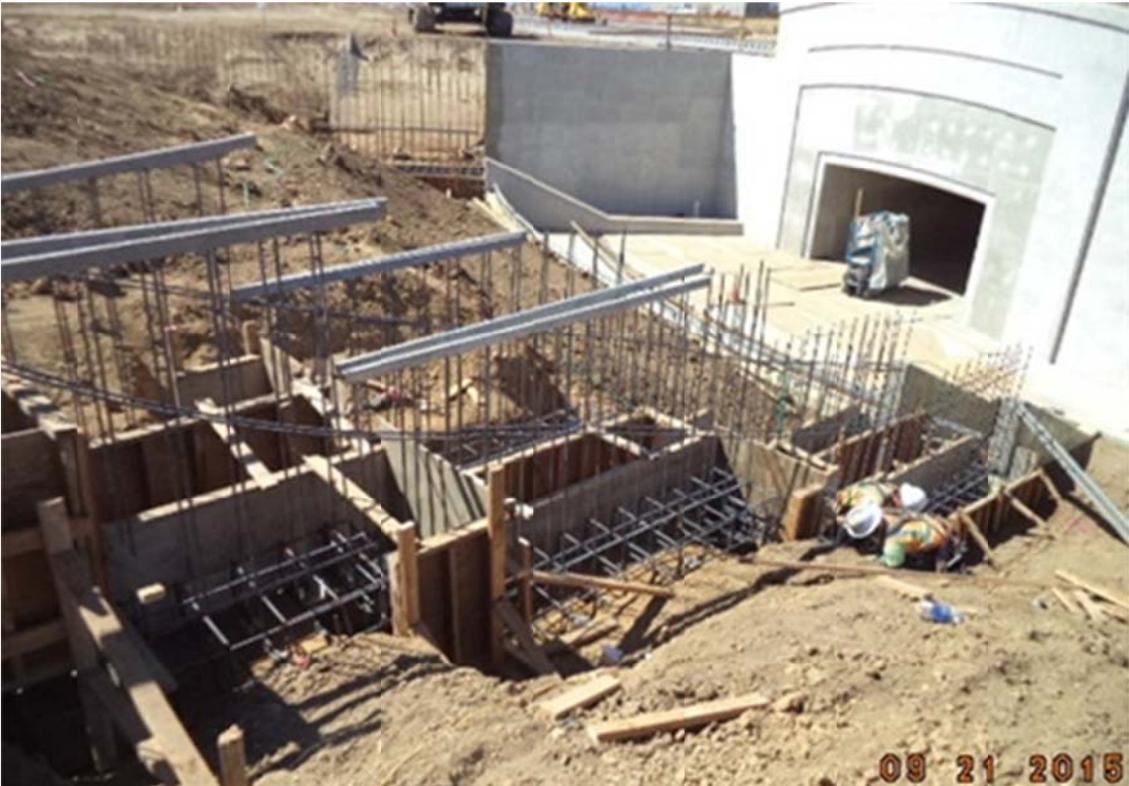
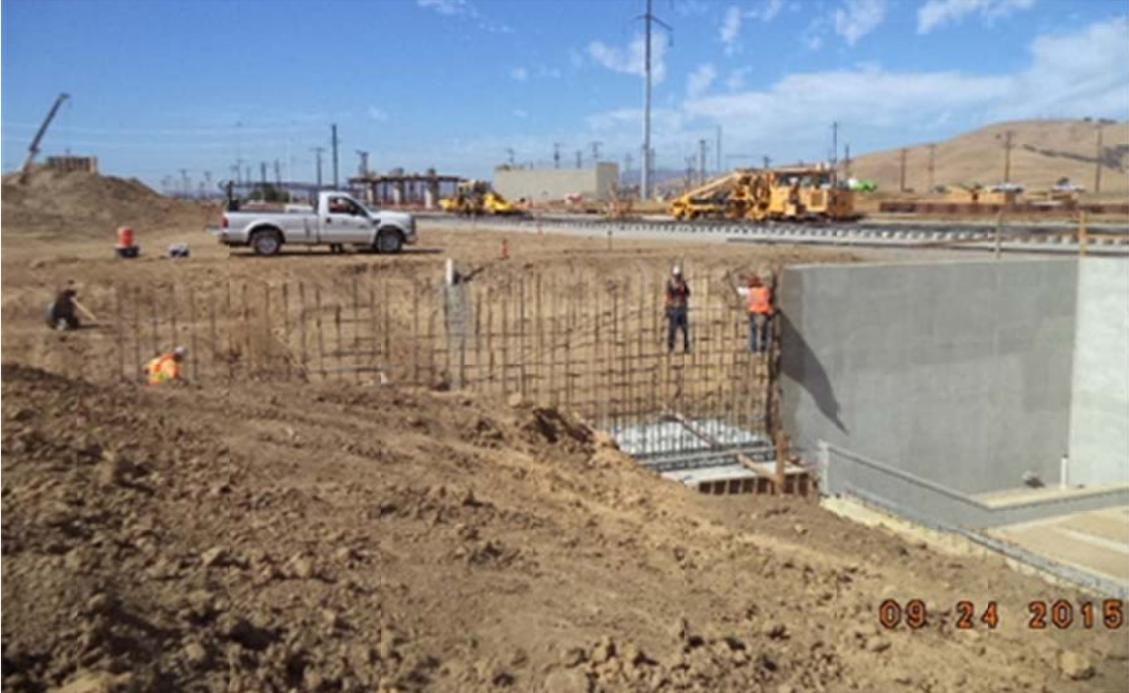
Photo above displays the south portal planter footing form work. Photo below shows the contractor installing the reinforcing for the south-west retaining wall at the South Portal. Also, in the background of this photo you can see UPRR equipment building the new railroad tracks.

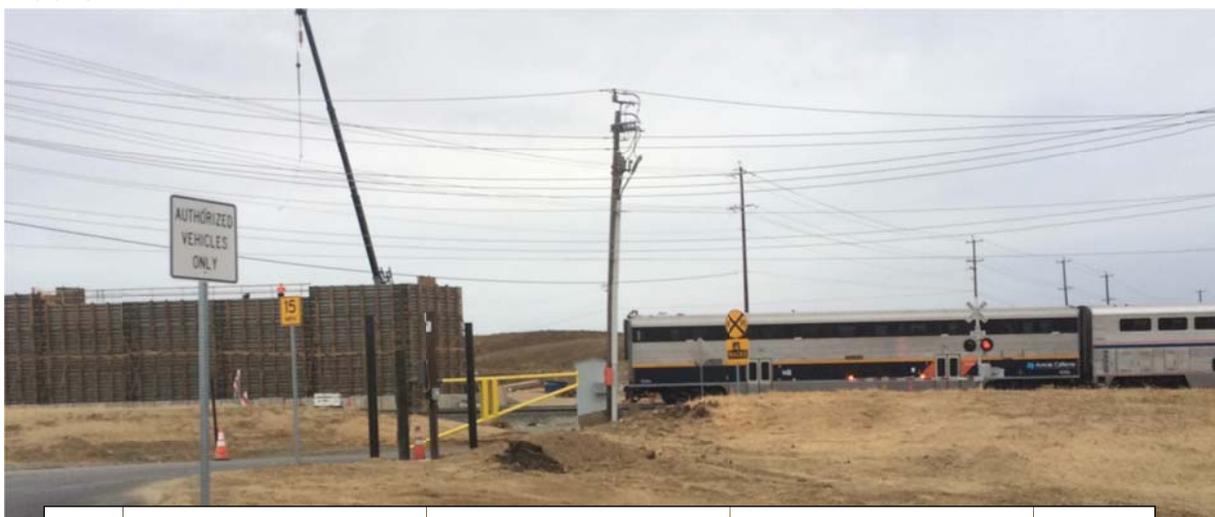
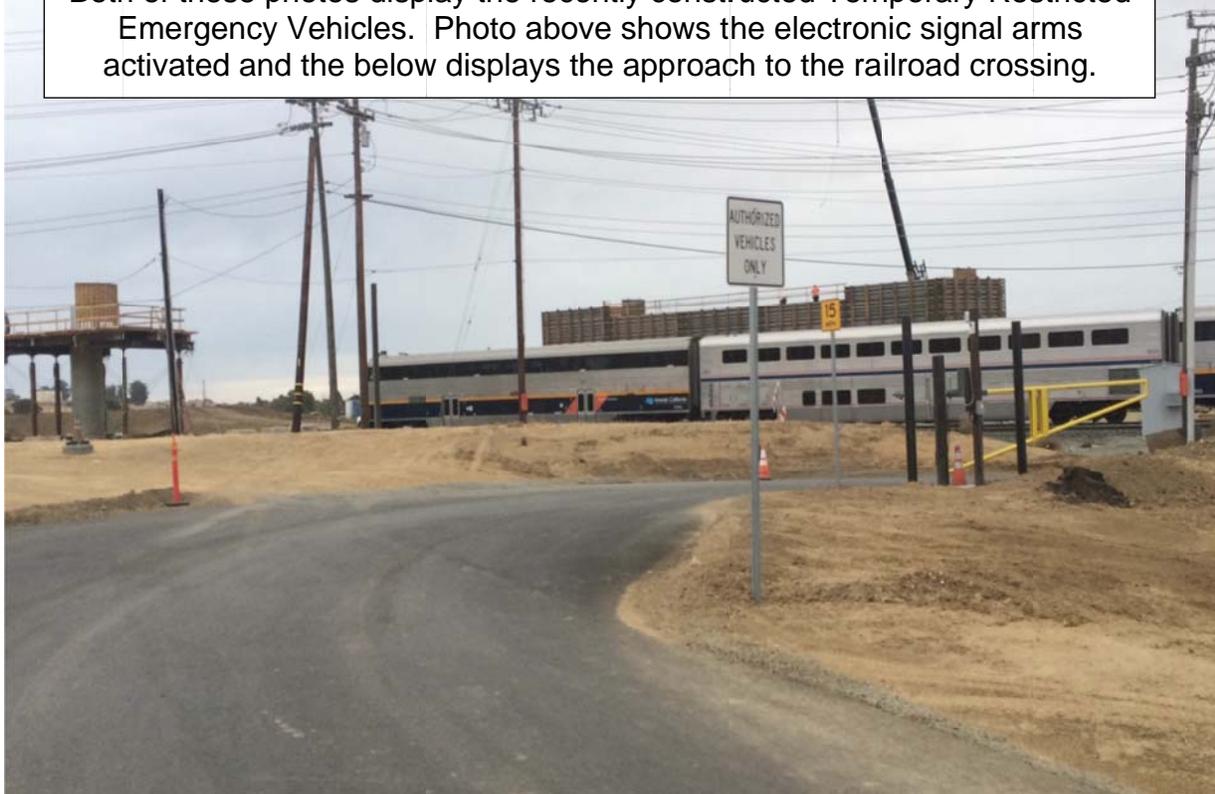
Both of these photos display the recently constructed Temporary Restricted Emergency Vehicles. Photo above shows the electronic signal arms activated and the below displays the approach to the railroad crossing.

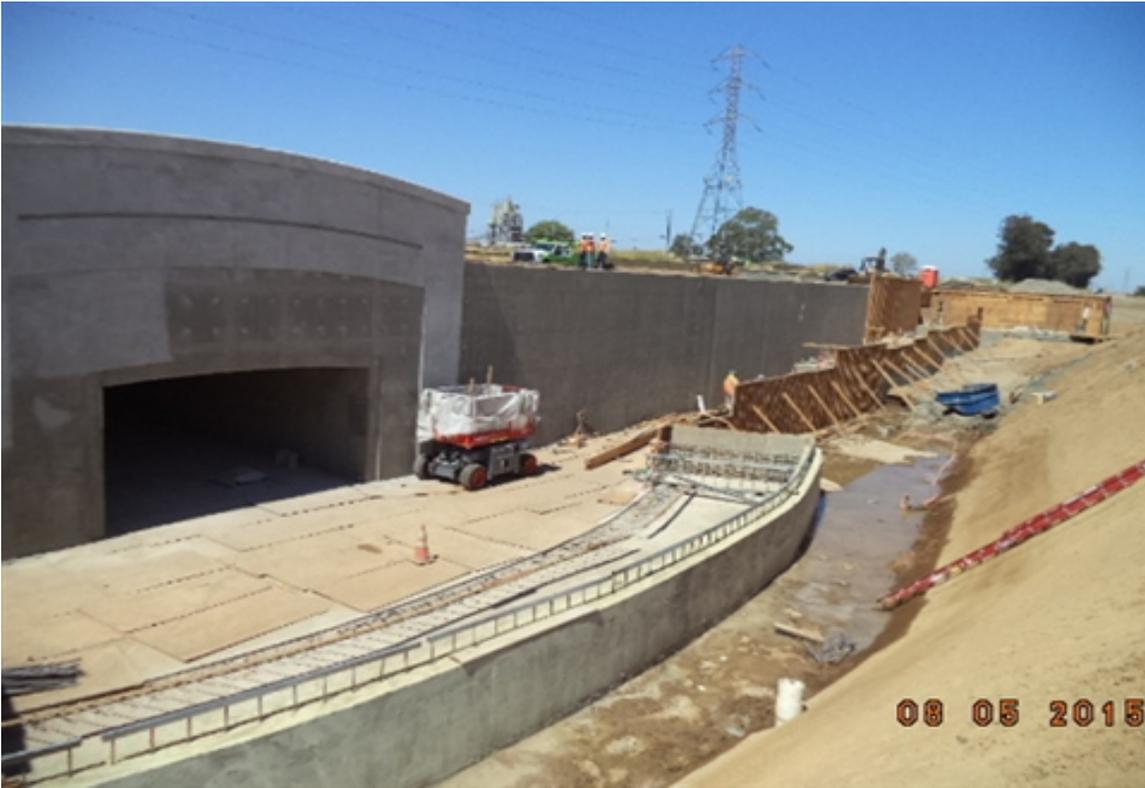
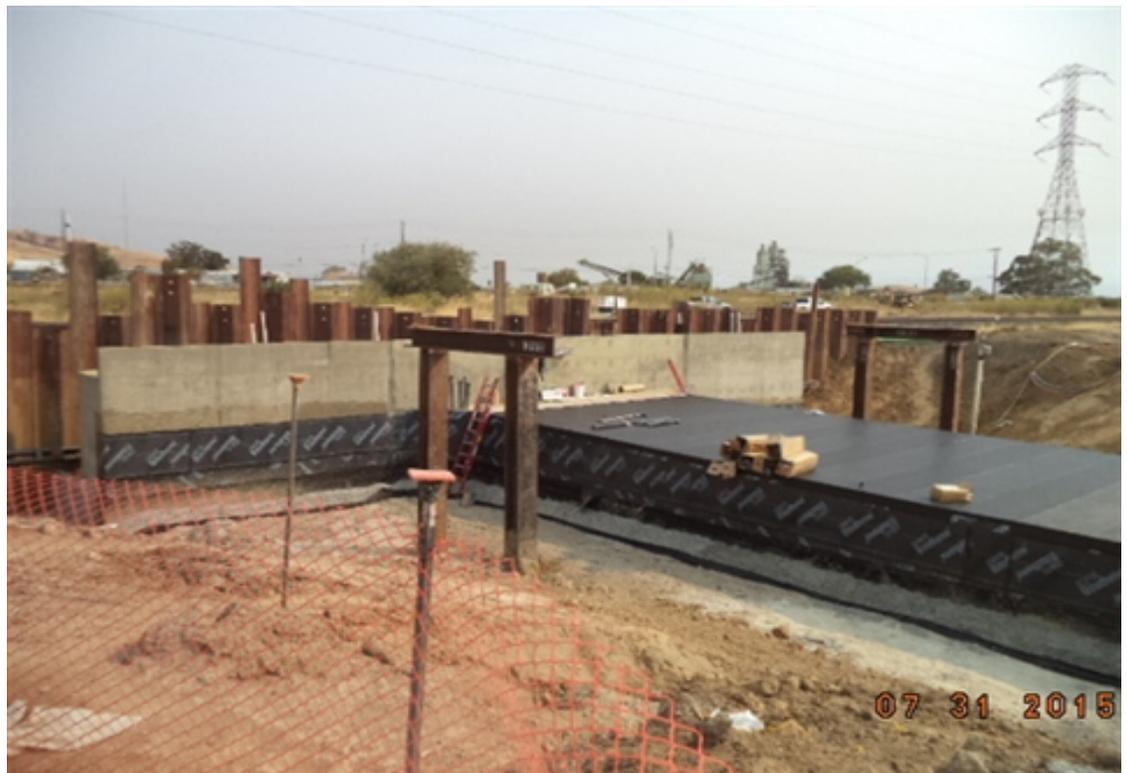
Photo at left displays the progress at the South Portal to the Pedestrian Underpass. Contractor is working on completing the ADA ramps, setting forms for the planters, and finishing the exposed concrete.

Photo at right displays progress at the south pedestrian underpass. Contractor is completing the membrane waterproofing installation. Once this work is completed it will be backfilled and UPRR will construct new railroad tracks over at this location.

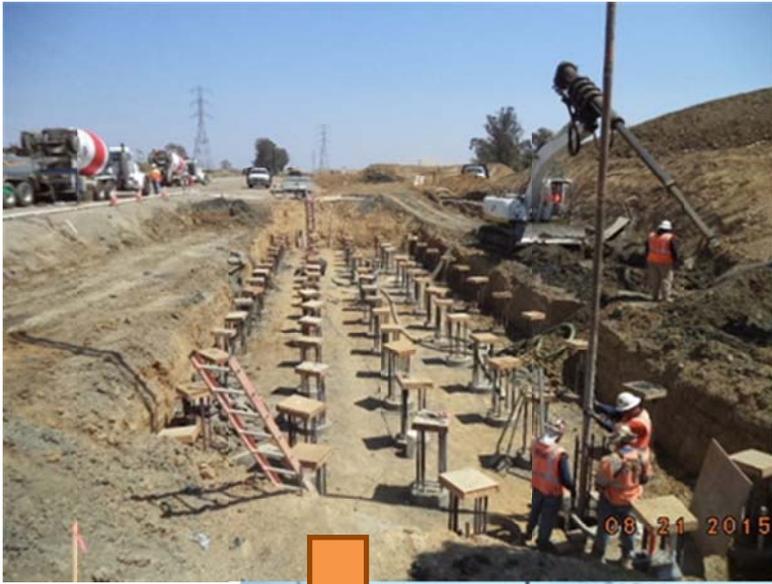
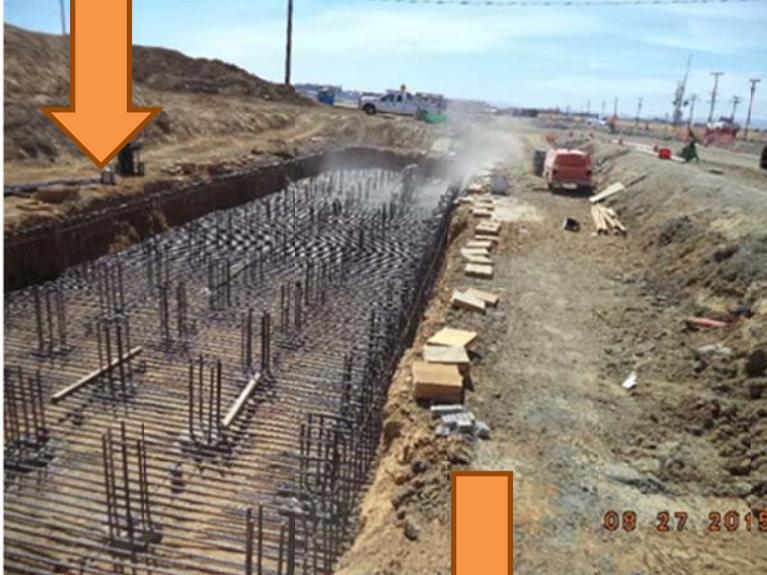
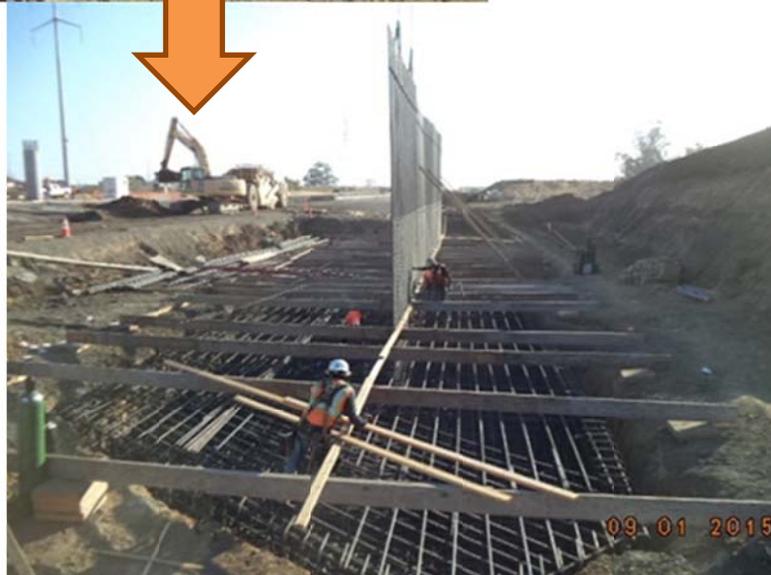
Photos display the progression of work at Abutment #1, located south of the Railroad tracks. Top photo (08-21-15) displays the completed 24" CIDH piles. Middle photo (08-27-15) shows the bottom mat reinforcing steel installed and the bottom photo (09-01-15) shows reinforcing steel installation and template layout.

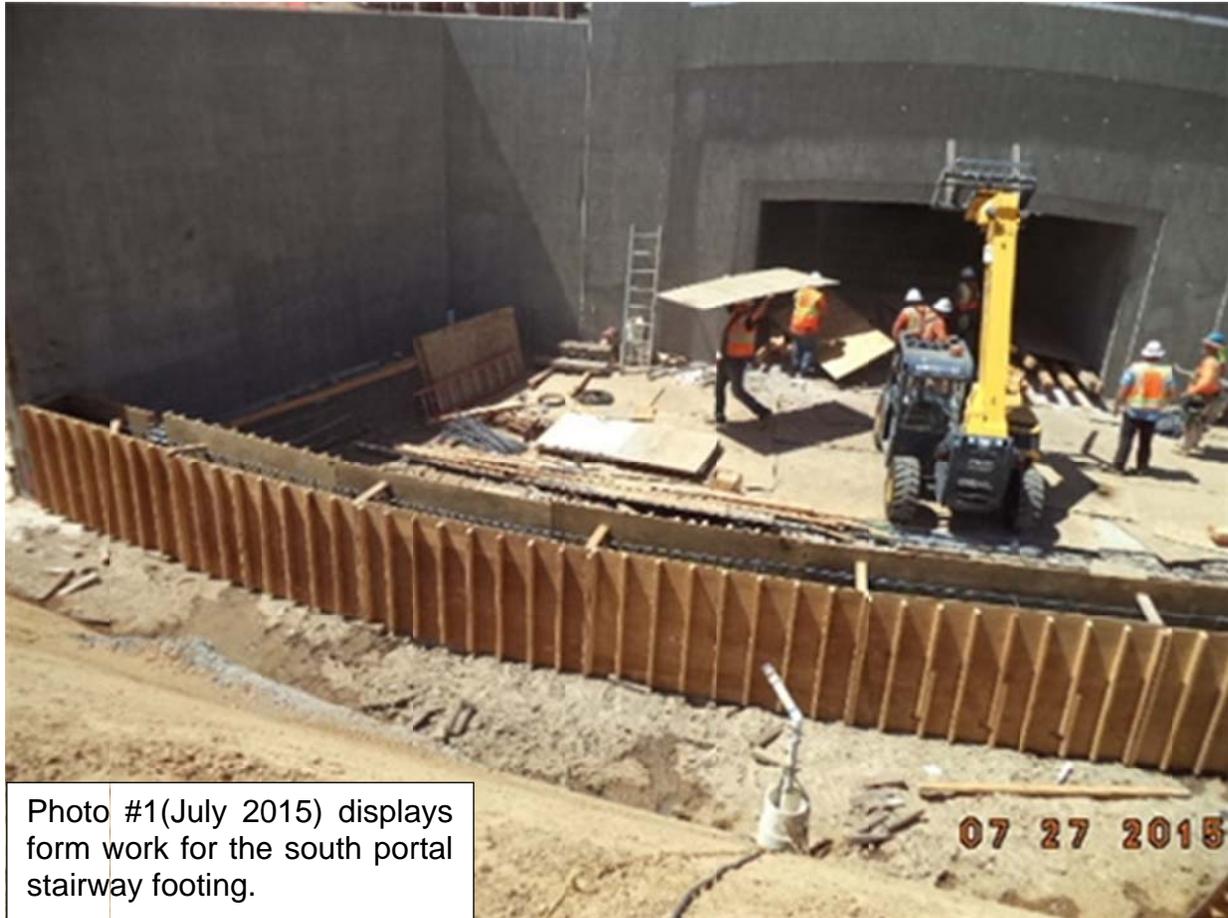
Photo #1(July 2015) displays form work for the south portal stairway footing.

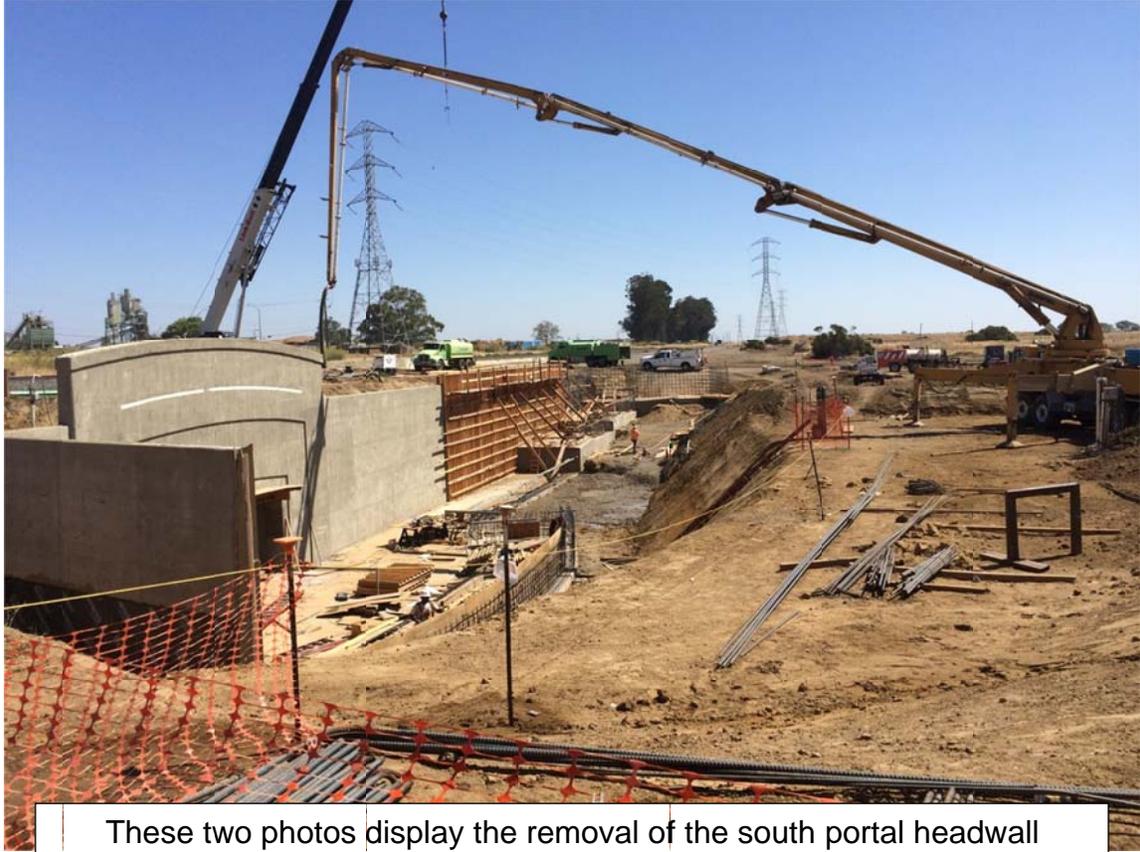
These two photos display the removal of the south portal headwall falsework and the equipment used to pour the structural backfill

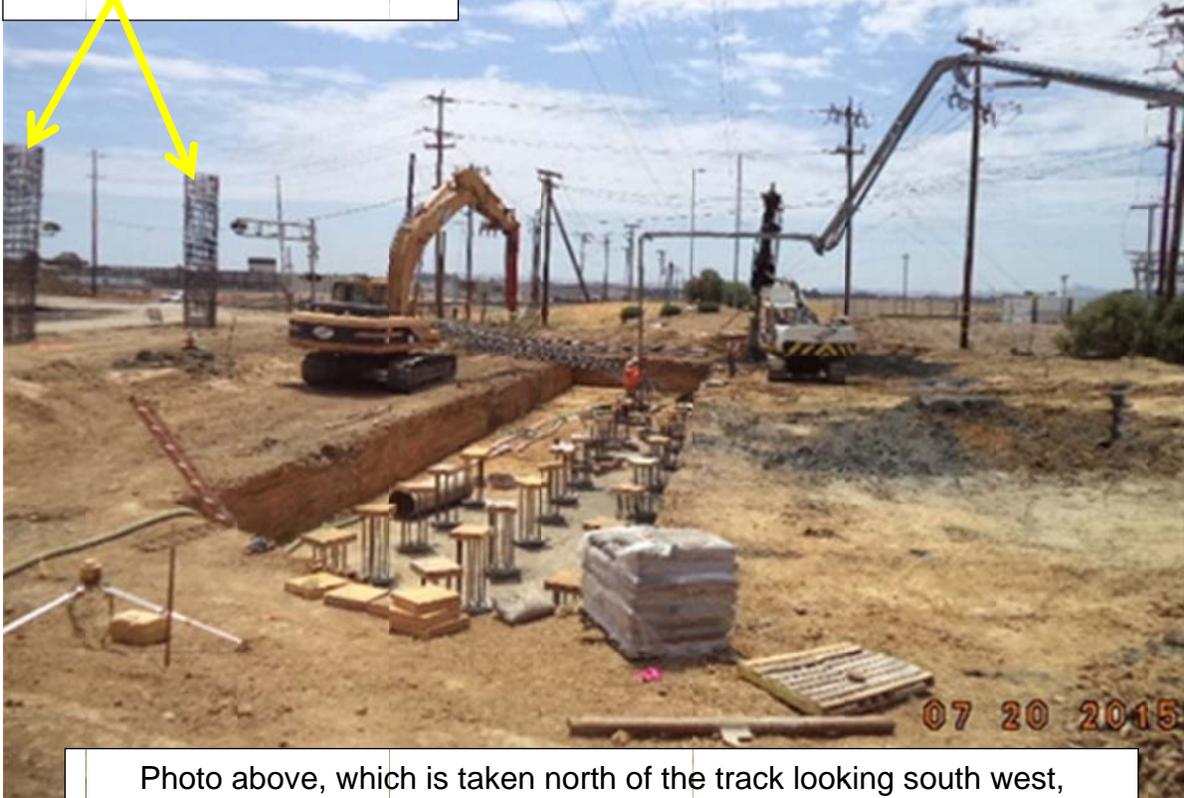
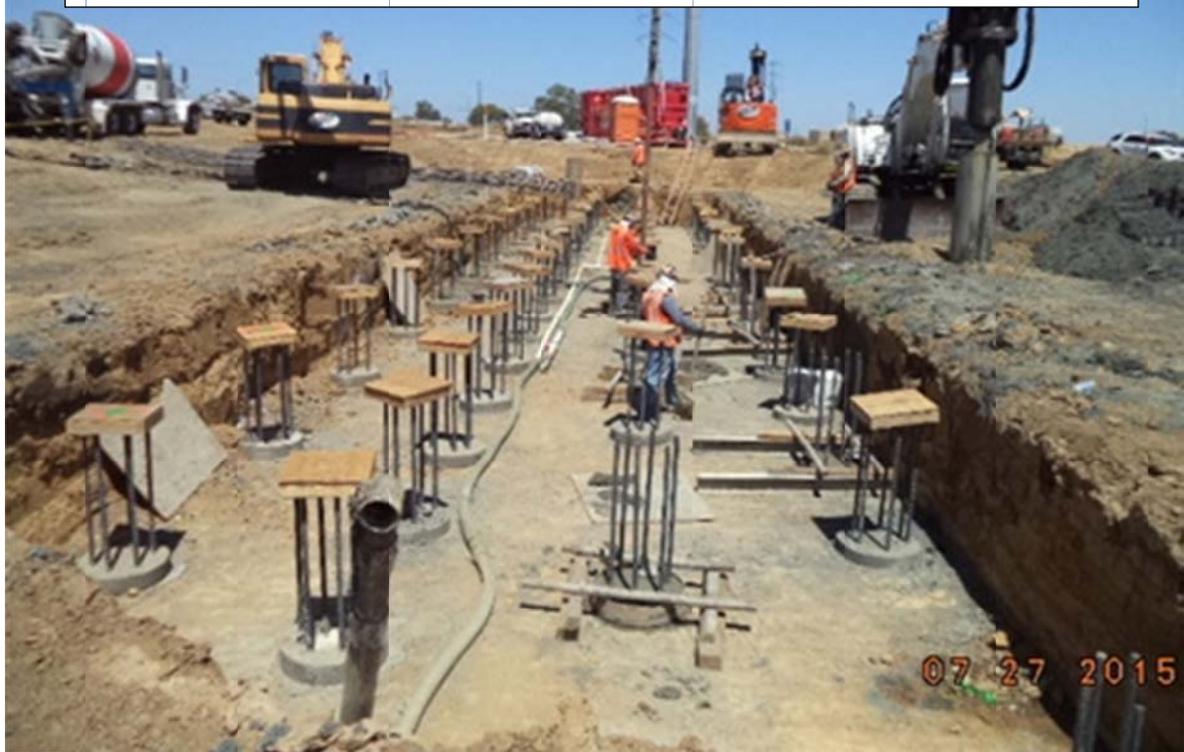
Photo above, which is taken north of the track looking south west,  
displays Abutment #4 of the Peabody Overpass. The photo below  
provides a closer view of the Abutment #4 and the 24" Cast-In-Drilled-  
Hole pile construction.

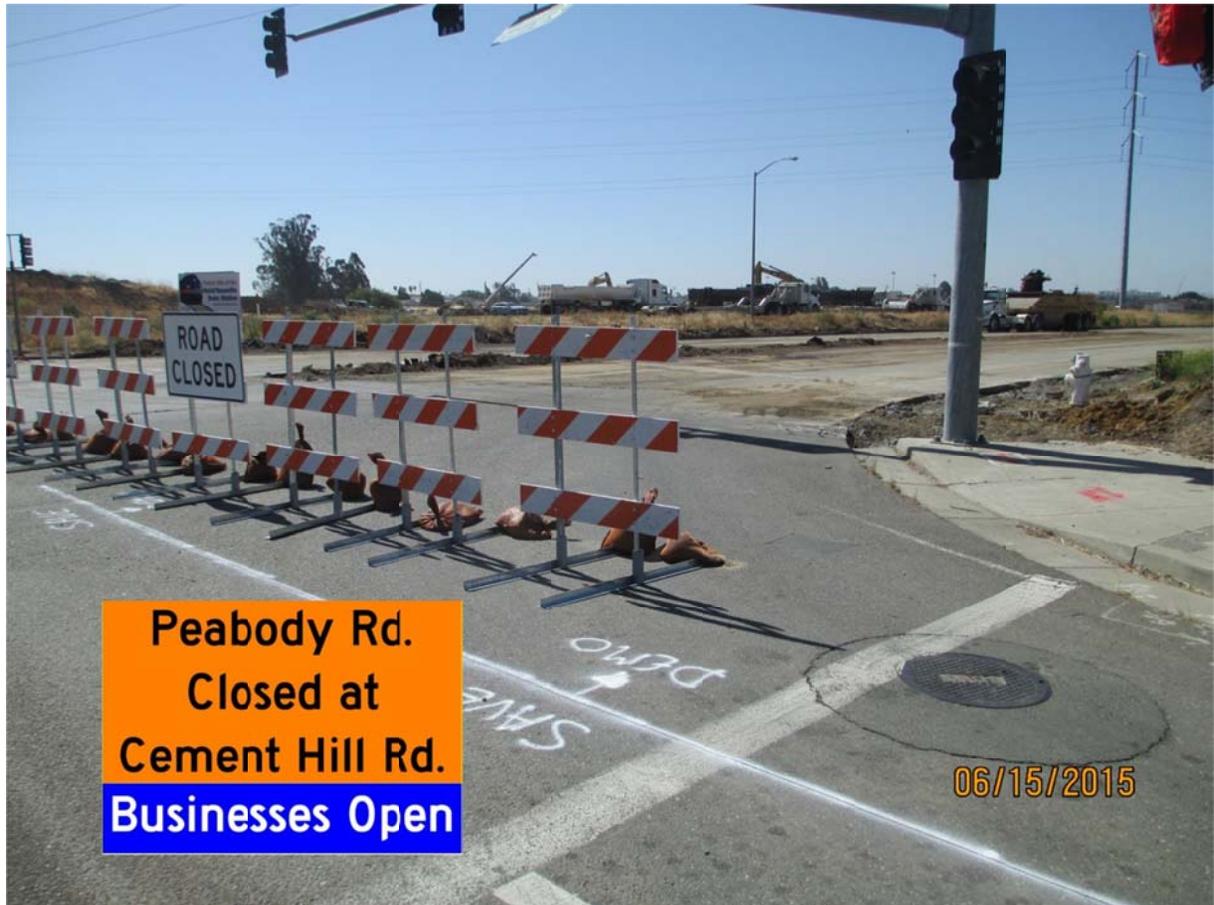
The installation of pavement markings, detour signage, and barricades associated with the Peabody Road closure was completed by the contractor the morning of June 12, 2015.
