## Fairfield / Vacaville Train Station and Peabody Road Improvements

### Current Construction Status (UPDATED 08-10-16)

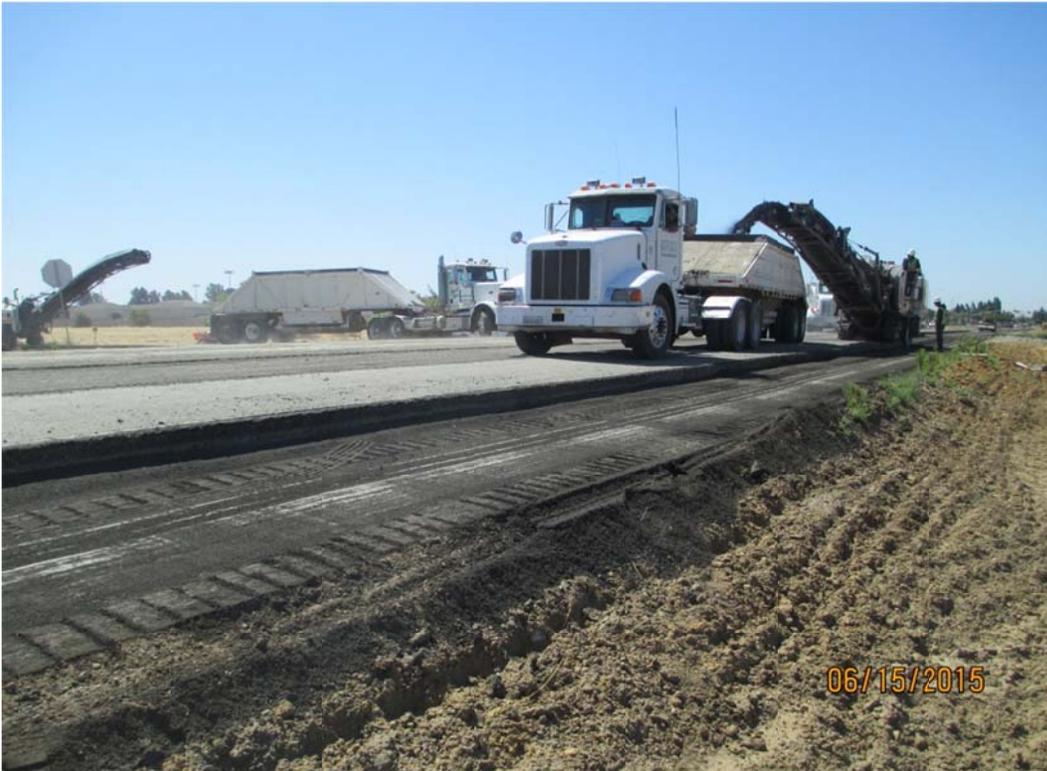
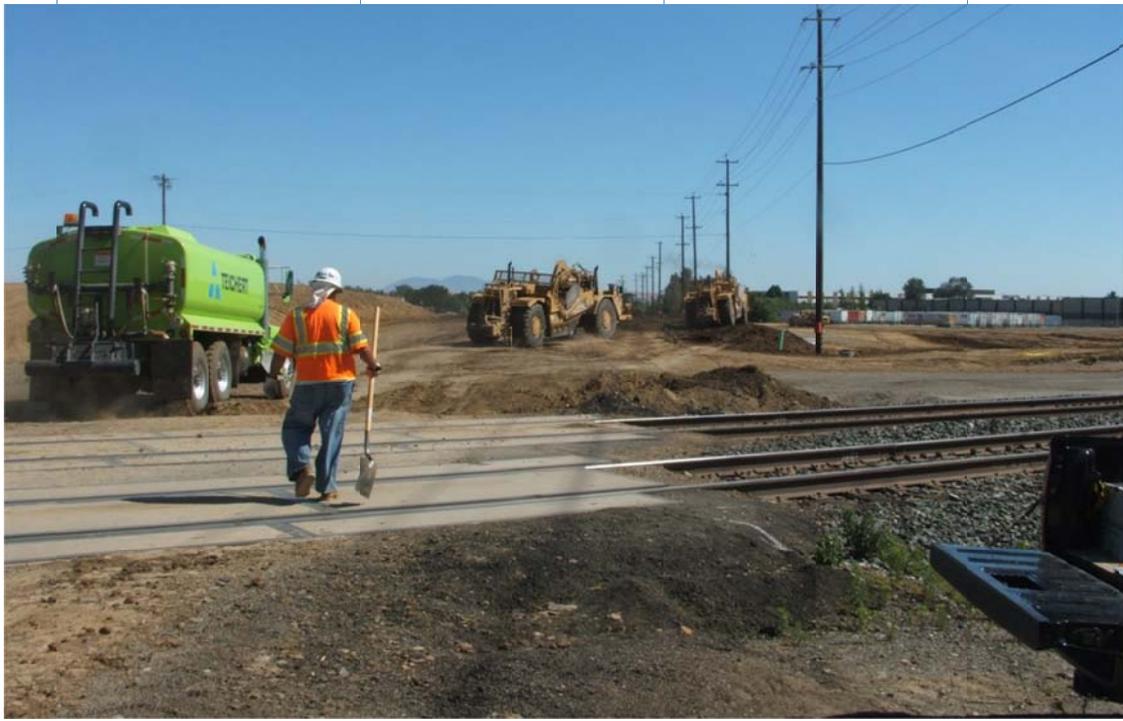
Photo above, taken on Peabody Road north of Markeley Lane, displays the removal of existing asphalt for the new overpass foundation. The photo below displays the earthmoving equipment and contractor personnel building the embankment and abutment on the south side of the railroad tracks.

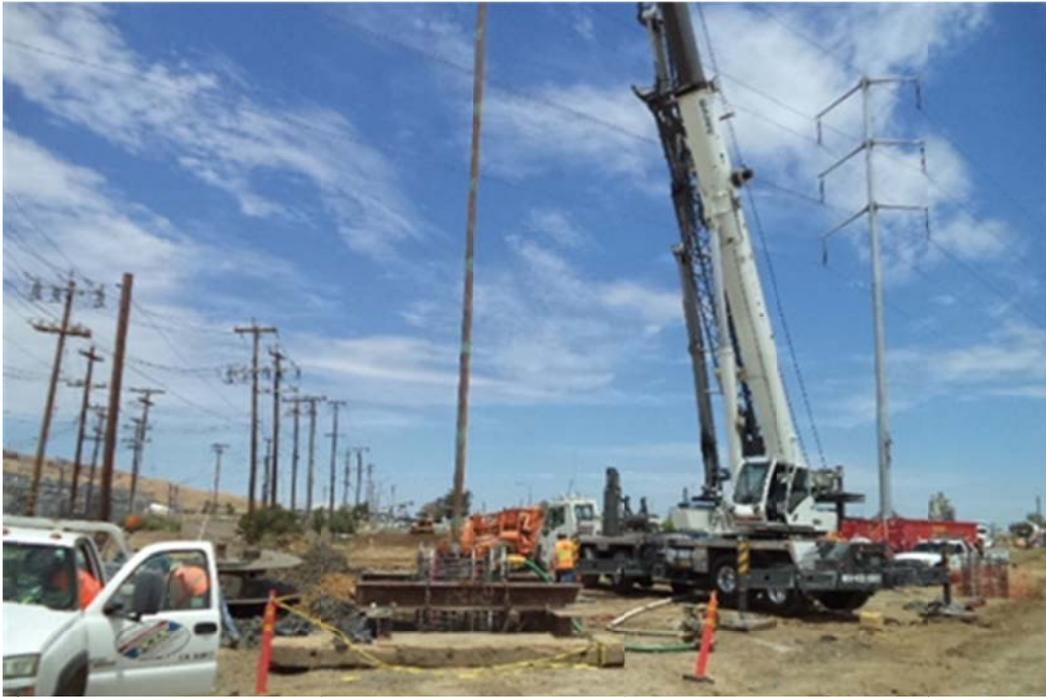
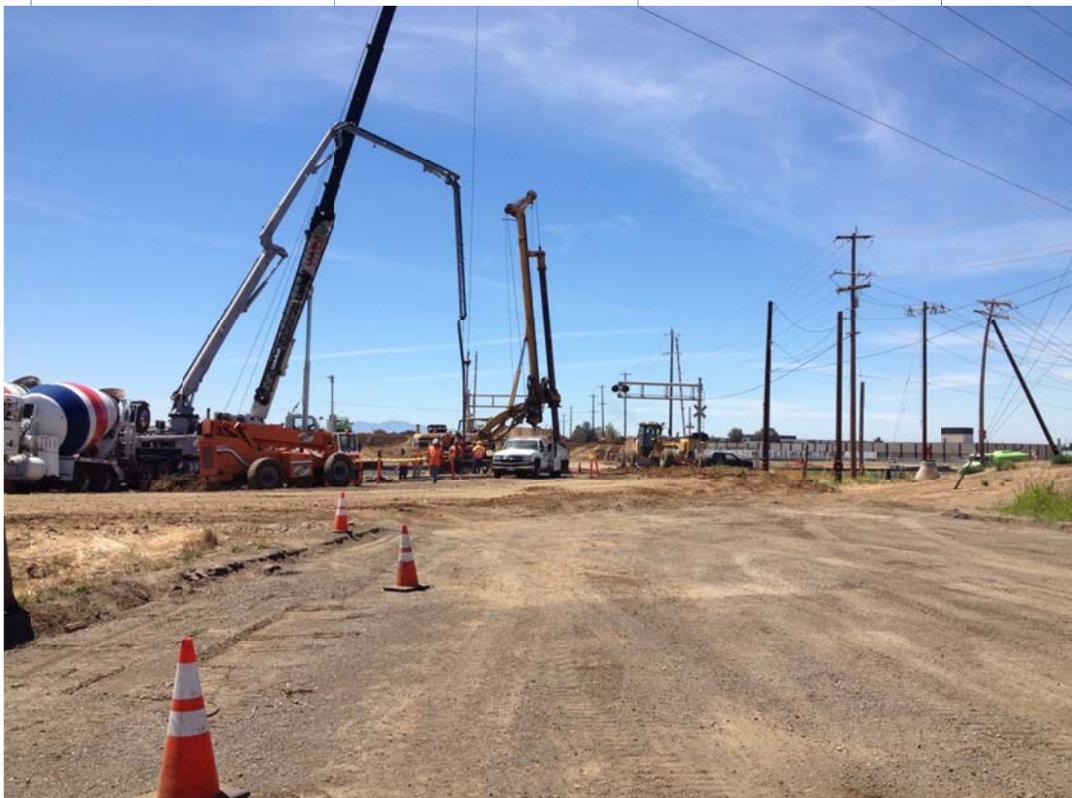
Contractor's crews working on the northern portion of the overpass and these photos show the cast-in-drilled-hole (CIDH) for the bridge foundation bridge.

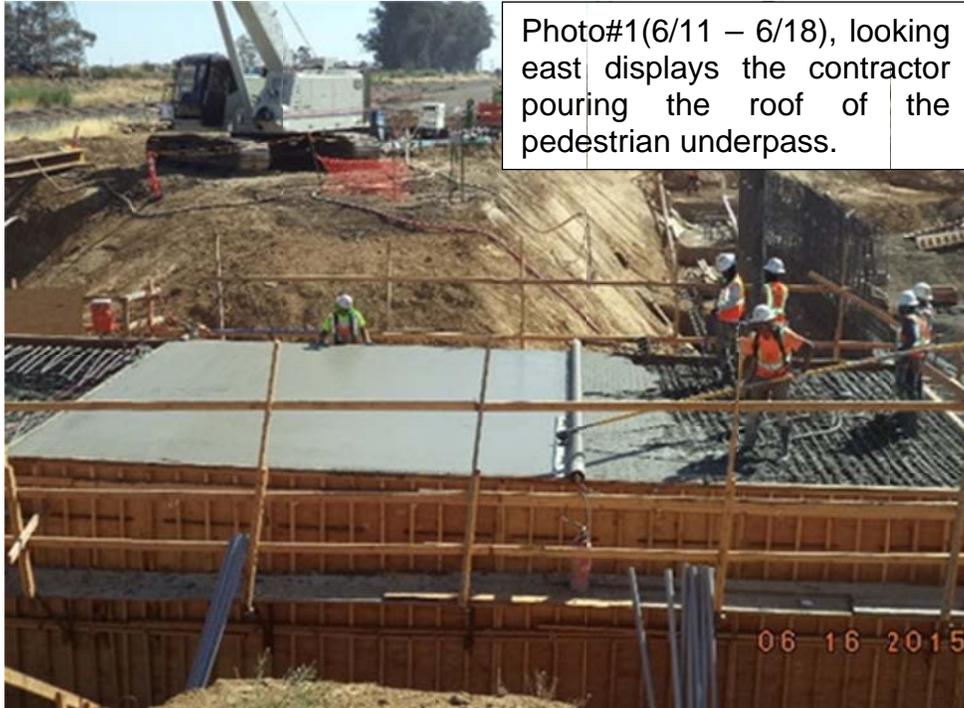
Photo#1(6/11 – 6/18), looking east displays the contractor pouring the roof of the pedestrian underpass.

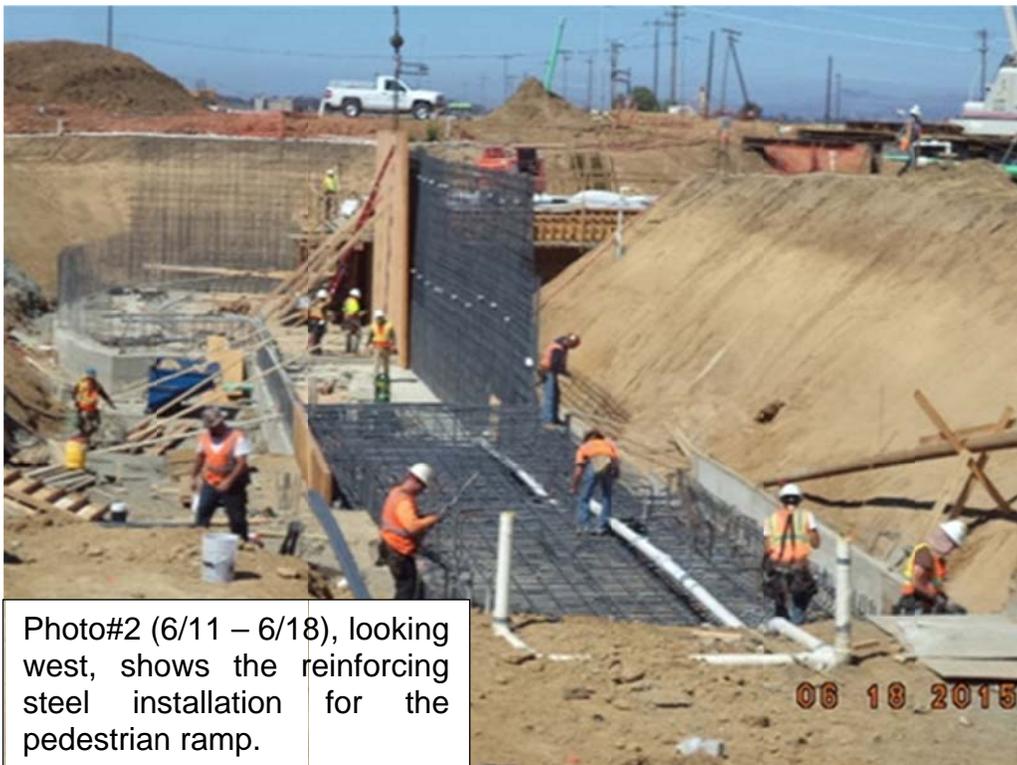
Photo#2 (6/11 – 6/18), looking west, shows the reinforcing steel installation for the pedestrian ramp.

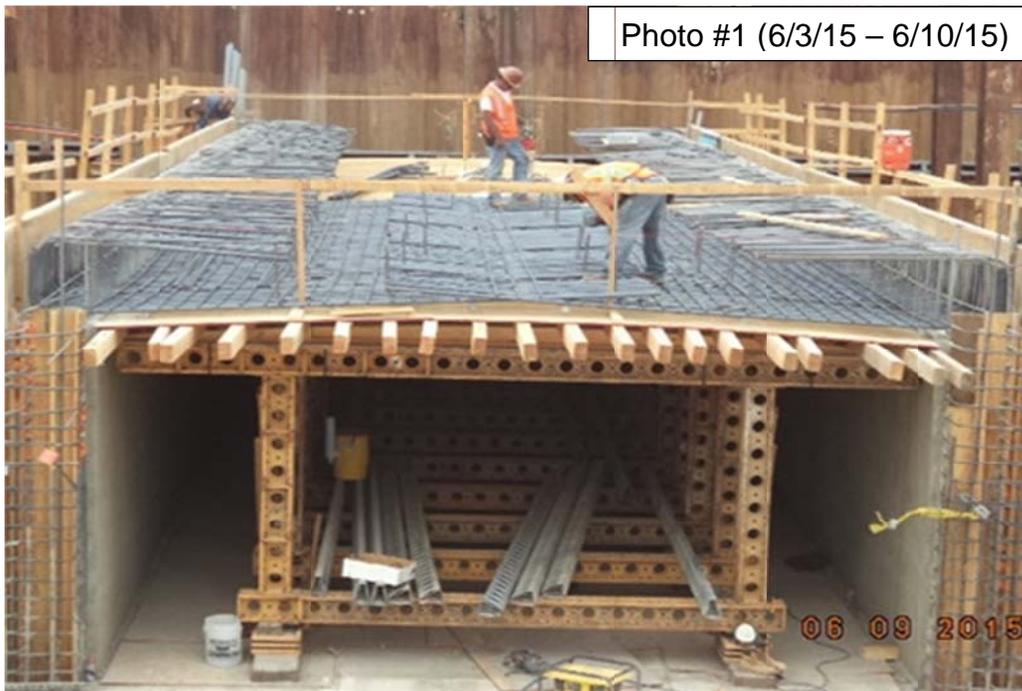
Photo #1 (6/3/15 – 6/10/15)

Work continues on the south pedestrian underpass. Photo #1 below, looking north, displays the installation of the false work in preparation for an upcoming concrete pour.

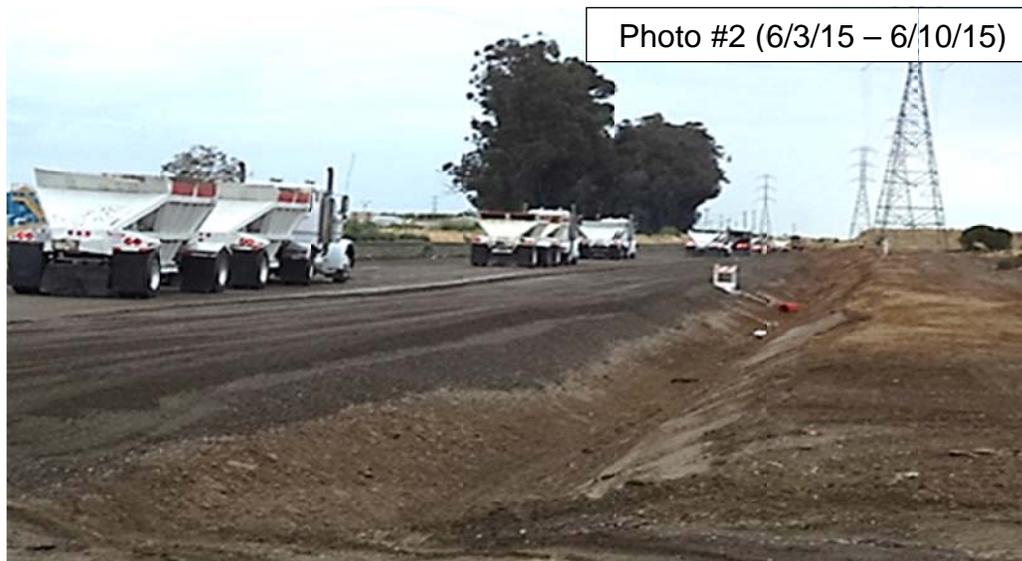
Photo #2 (6/3/15 – 6/10/15)

Photo #2, take on the south-east side of the tracks looking east, displays the graded subballast and swale. Also near completion is the rough grading and drainage improvements associated with the temporary restricted emergency access road. City anticipates Union Pacific Railroad construction crews to arrive early July to install the new tracks.

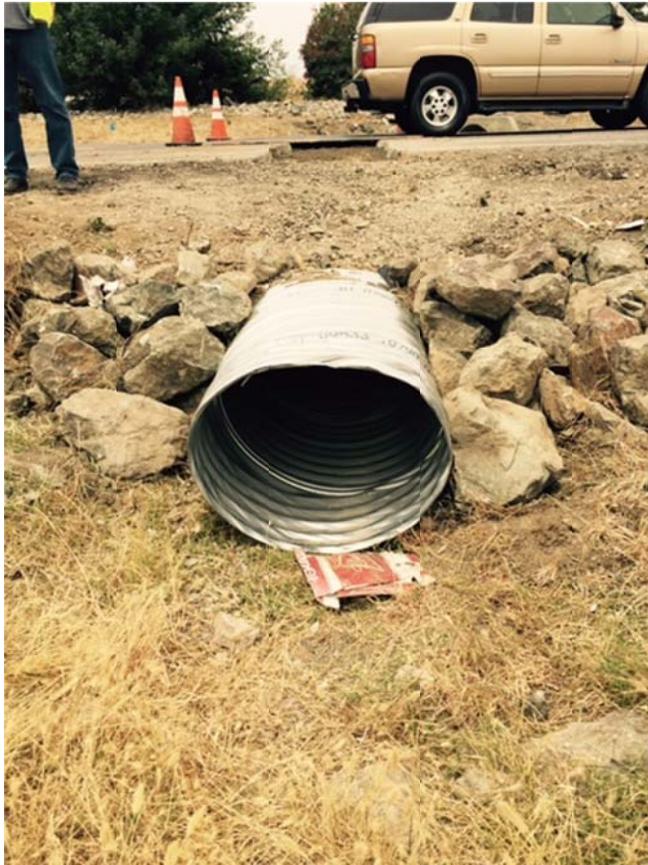
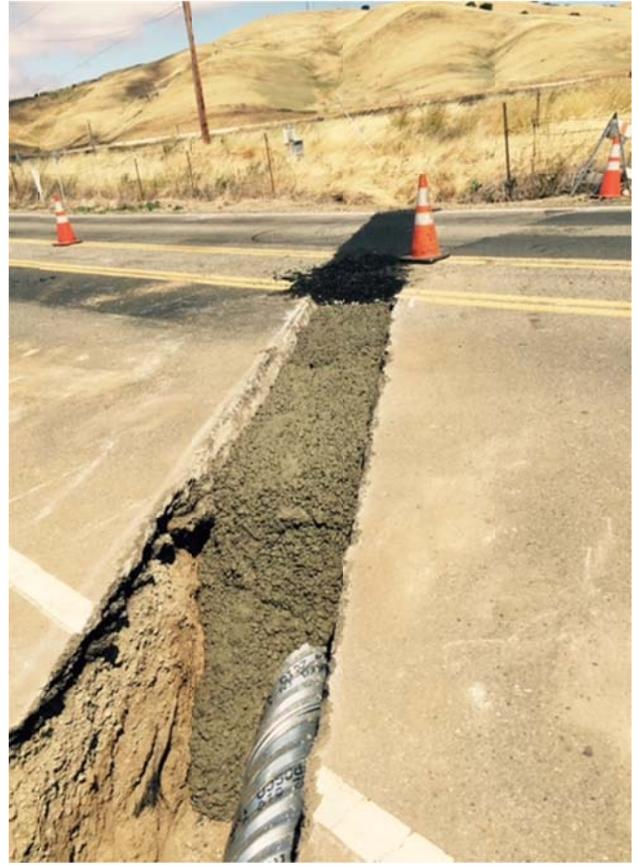
During this period City crews replaced four (4) culverts along Cement Hill Road from Peabody Road and Clay Bank Road. Cement Hill road is a major component of the detour route associated with the Project's schedule June 12<sup>th</sup> Peabody Road Closure. The culverts had reached the end of their service life and in need of replacement.

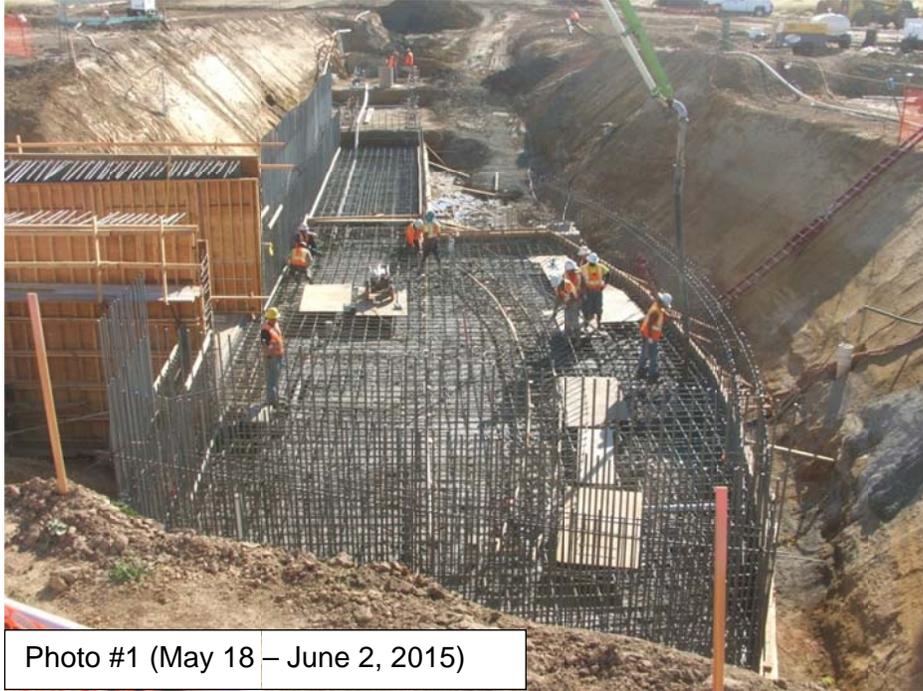
Photo #1 (May 18 – June 2, 2015)

The project's contractor started work on the South Portal, which includes stairs and an ADA ramp out from the underpass. Photo #1 (looking east) shows the placement of rebar and prep work for a concrete pour for the South Portal.

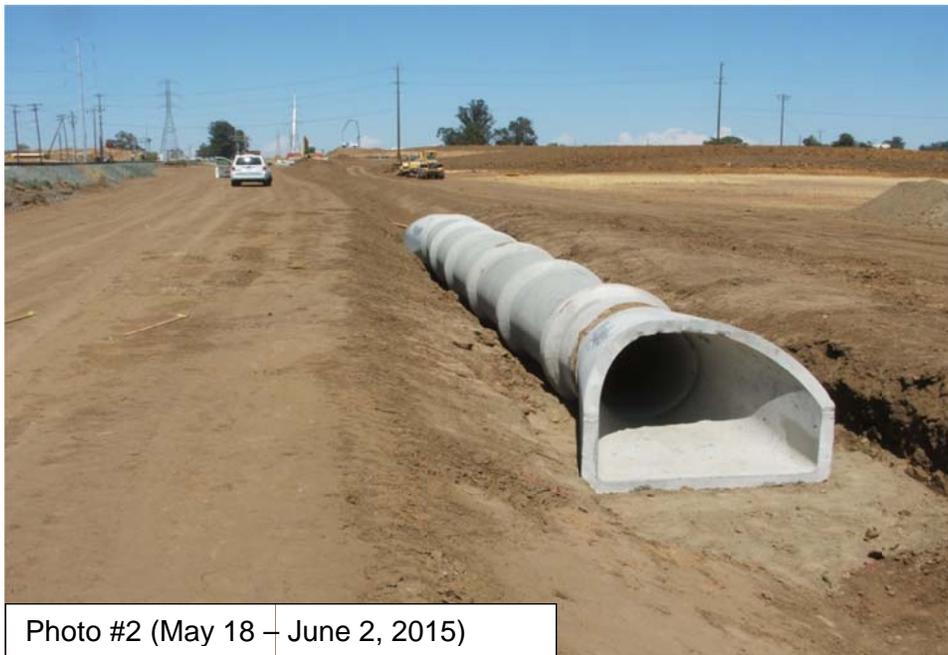
Photo #2 (May 18 – June 2, 2015)

The contractor has also started during this period, grading activities associated with the new railroad tracks that will be installed by Union Pacific Railroad. Photo #2 (looking east and on the west side of Peabody Road) displays drainage improvements for the future track.

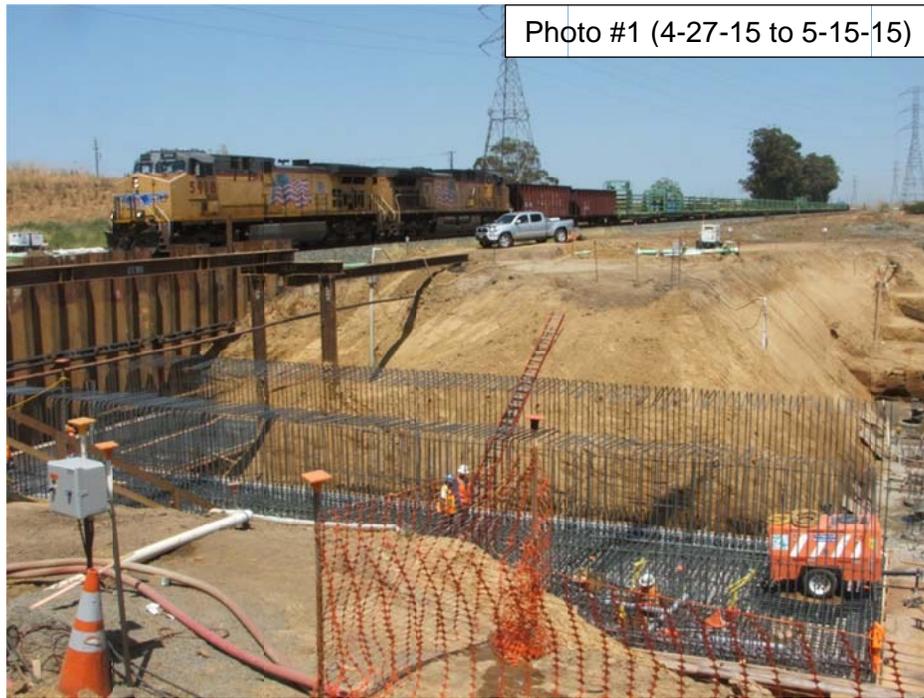
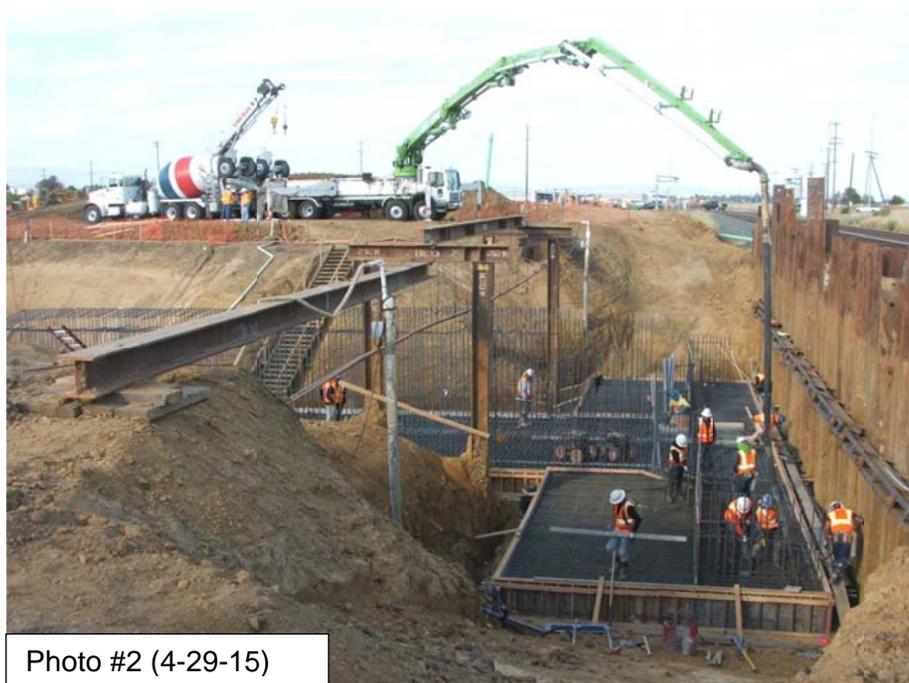
The abnormally dry weather has allowed significant progress in construction of the south pedestrian underpass. Photo #1 (looking east) displays the contractor installing rebar for the pedestrian underpass. This photo also shows Union Pacific Railroad delivering the project's track material. Photo #2 (looking west) displays crew pouring concrete for the pedestrian underpass finish floor.

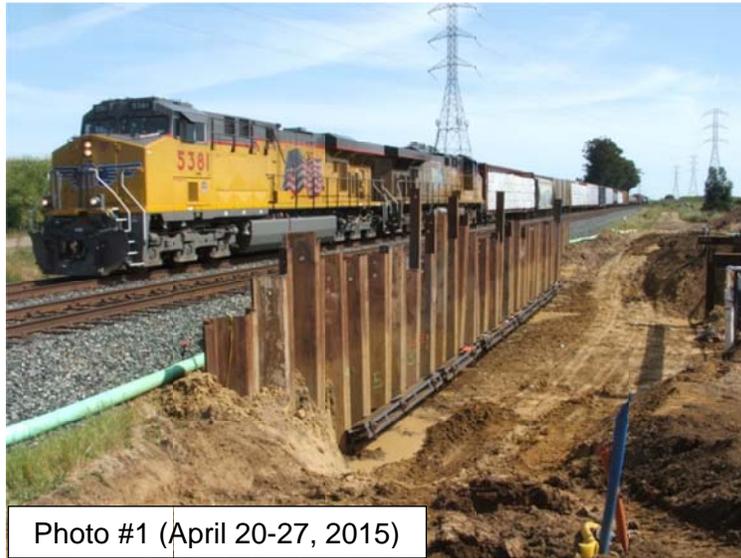
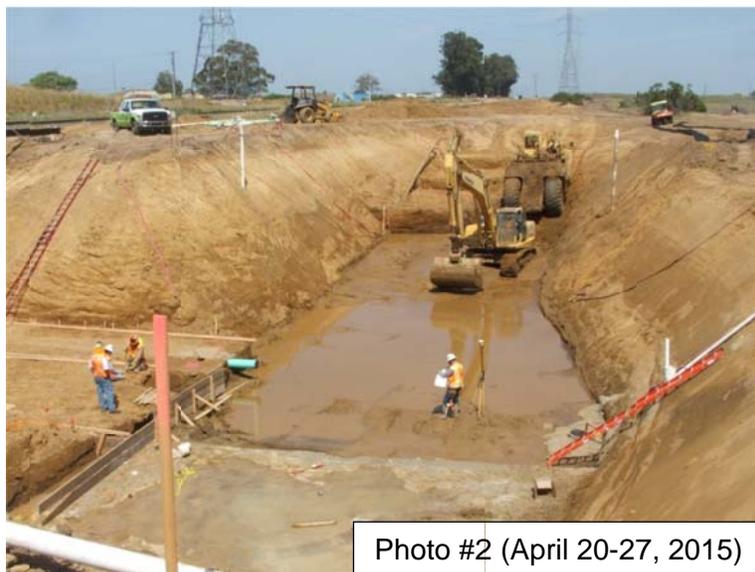
Work continues on the pedestrian underpass on the south side of the railroad tracks. Photo #1 (looking west) below shows the installed sheet piles that support the south side of the railroad tracks during construction. Photo #2 (looking north-west) displays the excavation work for the pedestrian underpass.

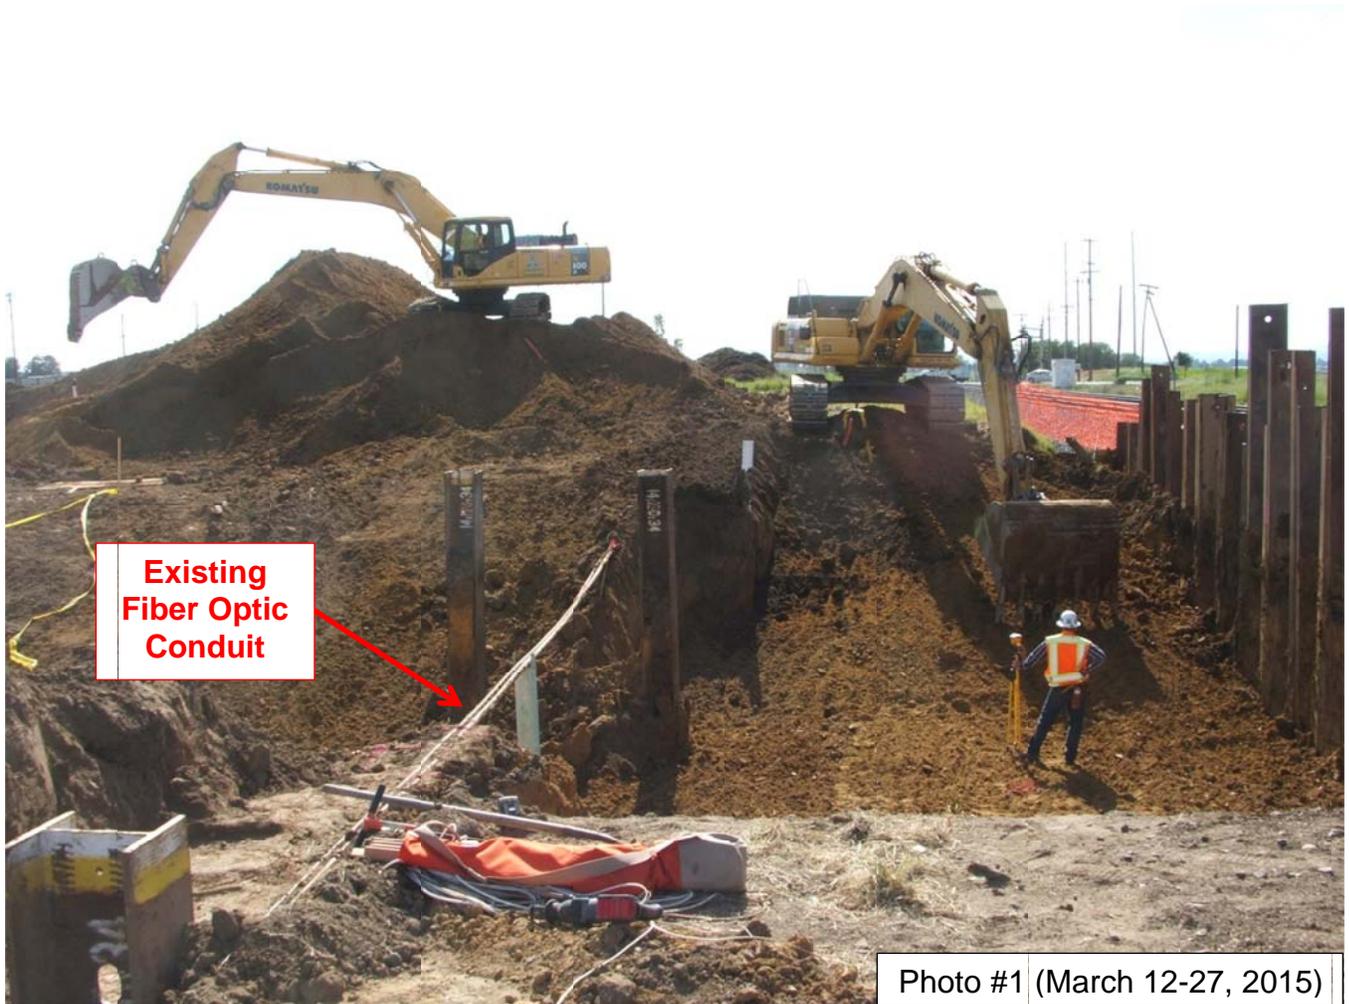
Photo #1 (March 12-27, 2015)

The Contractor and CM Team continue to coordinate with the various utility companies to locate all below ground utilities within the vicinity of the south pedestrian underpass. Photo #1 (taken on the south side of the railroad tracks looking west) displays the support system constructed by the contractor for the existing fiber optic conduit to remain.

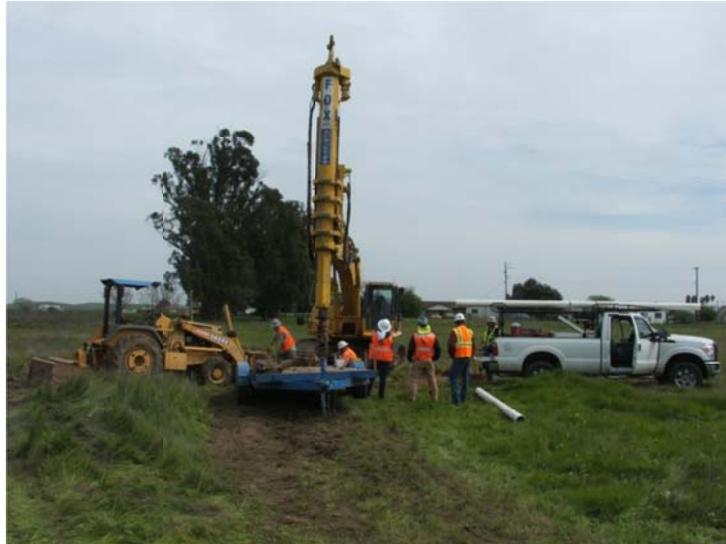
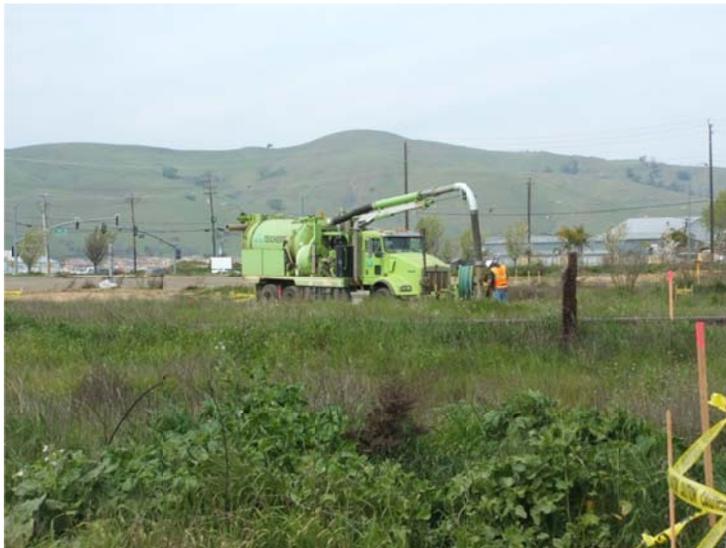
Great news! The City has issued the official Notice to Proceed to the contractor Teichert / Myers JV. The contractor this week worked on the environmental fencing, storm water protection devices, establishing dewatering systems, and install sheet piles for the new pedestrian undercrossing. Our project team continues to meet each week and pushing forward with submittal, contract clarifications, and shop drawing reviews. The railroad (UPRR) and its representatives have continued to partner with us on this important project for the community.

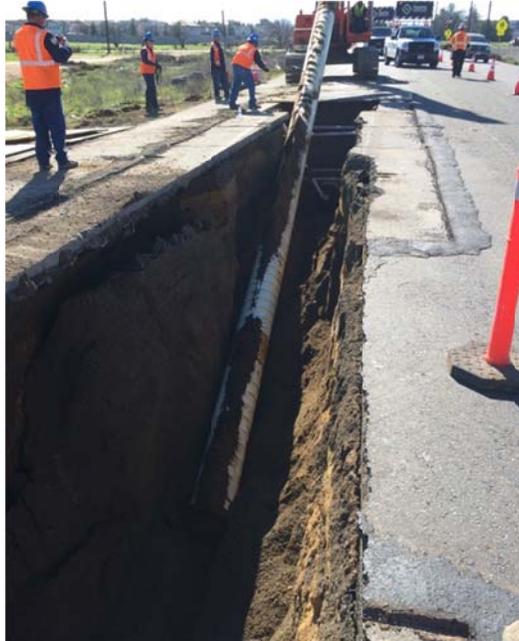
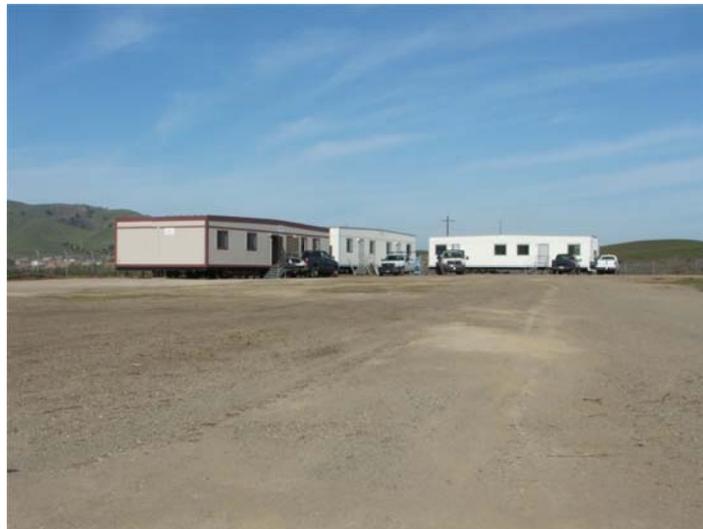
During the first week of February, Kinder Morgan removed sections of an abandon pipeline to make room for the new bridge footings. In addition, construction offices have been installed near the site in preparation of field personnel.
